# Failure analysis of a crude oil pipeline

Cesar R.F. Azevedo \*

*Department of Metallurgical and Materials Engineering, Escola Politécnica da Universidade de São Paulo, Brazil*

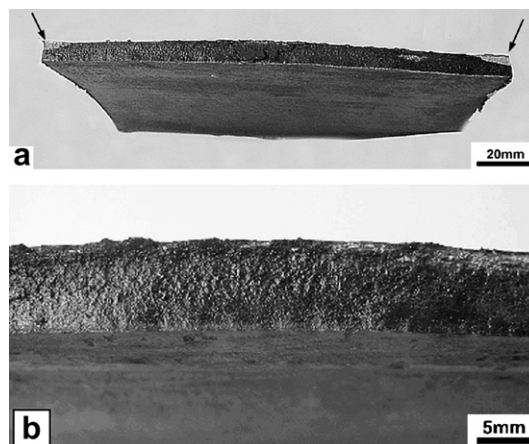
The cracking was nucleated on the internal surface of the pipeline, propagating in a stable mode in both radial and longitudinal directions, the latter along the heat affected zone (HAZ) of the seamed steel tube. Non-destructive inspection (magnetic particles) indicated that the through-thickness crack featured a width of 220 mm in the internal surface and 140 mm in the external surface. Visual inspection did not show the presence of a plastically deformed region next to the crack (see Fig. 1a and b). Macrofractographic examination of the exposed surface of the primary crack (see Fig. 1b) revealed the presence of two regions:

- Region 1: plane region (stable crack propagation) with a semi-elliptical format up to a thickness of 7.1 mm, featuring the presence of a dark deposit, which is rich in Fe, O, Si and S (see Table 1);
- Region 2: shear-lip region (approximately 0.5 mm thick), also featuring the presence of a dark Fe-O-Si-S rich deposit (see Table 1), although the contents of O and S are comparatively lower.

Fig. 1. Visual inspection – longitudinal section, exposed surface of the primary cracking: (a) general view, arrows indicated fresh fracture induced in the laboratory. (b) Detail of the fracture surface showing predominant plane fracture and top edge featuring shear-lip.

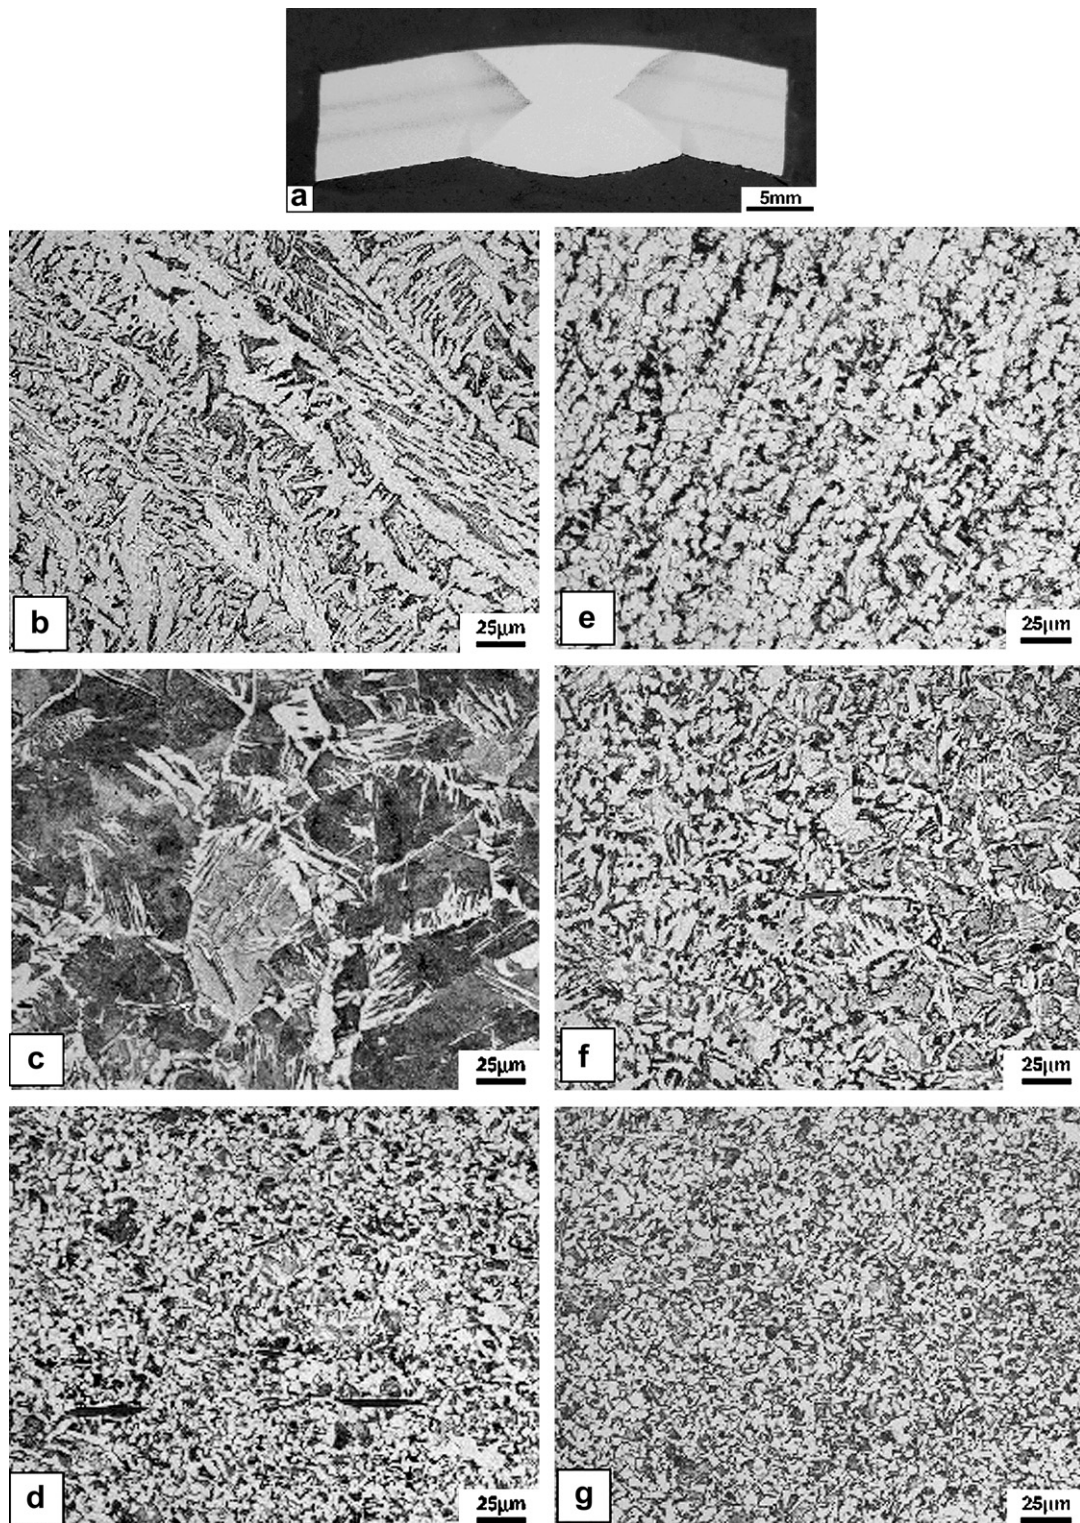
Macro and microstructural examination of a transversal section of the tube (see Fig. 2a–g) shows the presence of a two-step welding. The welded zone close to the external surface presents a columnar macrostructure, typical of as-cast material, featuring allotriomorphous and Widmanstätten ferrite and colonies of pearlite (see Fig. 2b), indicating that the last welding step was applied on the external surface. The adjacent HAZ region presents a microstructural gradient between two regions:

- Welding/HAZ interface: coarse microstructure composed of colonies of pearlite and allotriomorphous and Widmanstätten ferrite (see Fig. 2c);
- HAZ/metal base interface: refined microstructure composed of ferritic grains and colonies of pearlite (see Fig. 2d).

The welded zone close to the internal surface presents a recrystallised columnar macrostructure composed of ferritic grains and colonies of pearlite (see Fig. 2e), indicating that the first welding step was applied on the this surface. The adjacent HAZ region presents a microstructural gradient between two regions:

- Welding/HAZ interface: recrystallised microstructure composed of colonies of pearlite and elongated ferrite grains (see Fig. 2f);
- HAZ/metal base interface: microstructure composed of ferritic grains and colonies of pearlite (see Fig. 2g).

Fig. 2. Microstructural examination – nital etching – welding region – transversal section: (a) general view showing the presence of two-step welding; (b) external surface, welding region, as-cast microstructure; (c) external surface, welding/haz interface; (d) external surface, haz/base metal interface; (e) internal surface, welding region; (f) internal surface, welding/haz interface, recrystallised microstructure; (g) internal surface, haz/base metal interface.

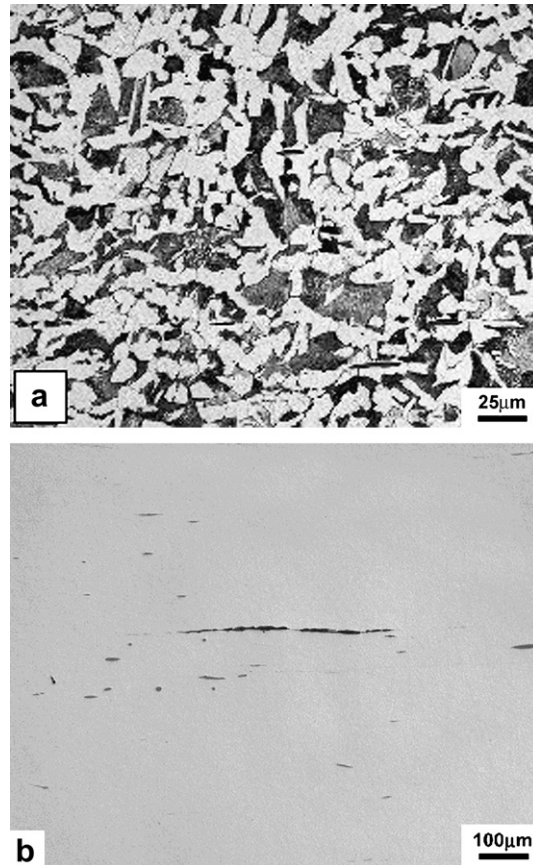
The microstructure of the tube is aligned along the plate deformation direction, being composed of ferrite grains, colonies of pearlite and sulphide inclusions (some up to 500  $\mu\text{m}$  long), see Fig. 3a and b. The inclusion content of the steel was identified as type A (sulphide) – heavy series – level 2; and type D (globular oxide) – thin series – level 2.

Fig. 3. Microstructural examination – base metal – longitudinal section: (a) ferritic pearlitic microstructure; (b) detail showing sulphide inclusion.

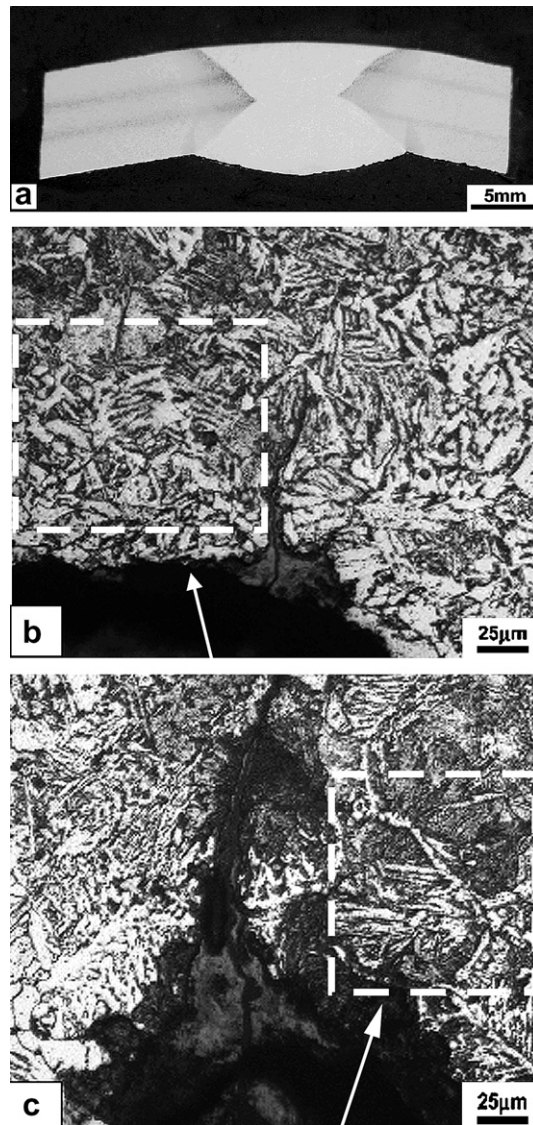
The internal surface of the tube presented cracking associated to the presence of welding defects (between 25 and 100  $\mu\text{m}$  deep) and corrosion pits (see Figs. 4a until c and 5c). HAZ regions located in same position along the internal surface of tube presented different microstructures, from ferritic microstructure to pearlitic microstructures with intergranular ferrite (see Figs. 4b and c), indicating that the thermal input during the welding process was not kept constant, causing microstructural asymmetries along the HAZ regions. Fig. 5a and b showed that the direction of crack propagation does not depend on the macrostructure, as the primary crack nucleates on the welding/HAZ interface and grows perpendicular to both the internal surface and the main tensile stresses, propagating along the diverse HAZ and base metal regions.

Fig. 4. Microstructural examination – nital etching – welding region – transversal section: (a) general view; (b) and (c) detail of the haz/welding region of the internal surface, left (b) and right position (c), showing transgranular cracking associated to the presence of superficial irregularities (corrosion pits – see arrows). Additionally, symmetrical haz regions present different microstructure (compare dotted areas).

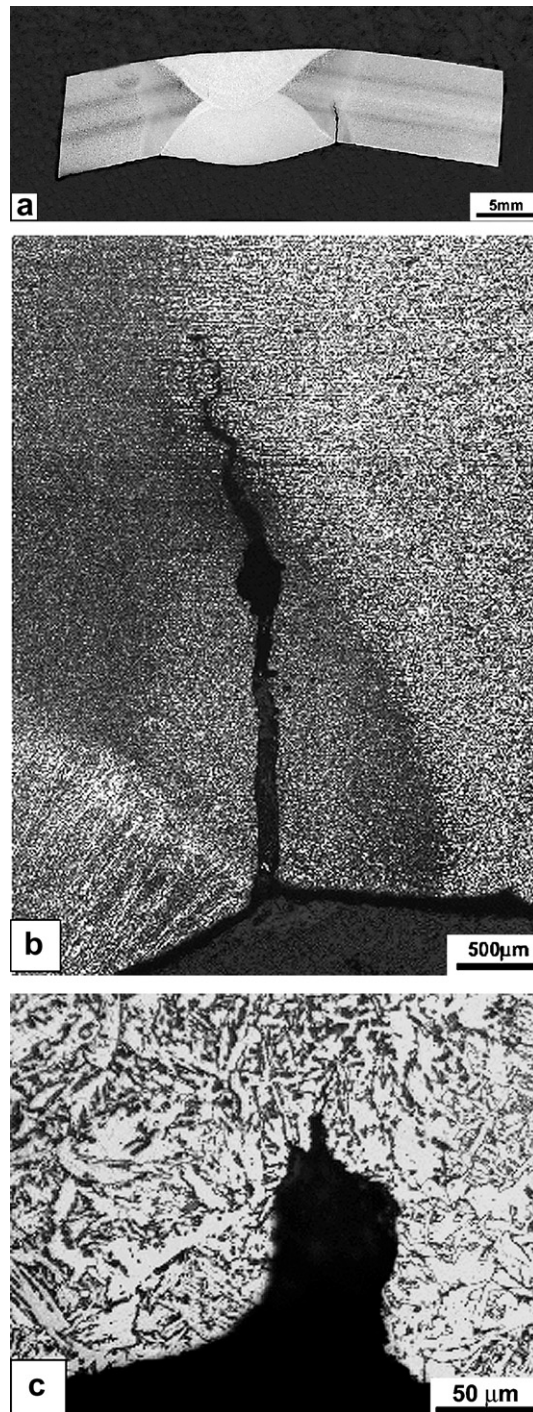
Fig. 5. Microstructural examination – nital etching – welding region – transversal section: (a) general view showing primary cracking; (b) and (c) detail of the haz/welding region of the internal surface, right (b) and left position (c) showing detail of crack propagation path along the haz region (see (b)) and cracking associated to the presence of a welding defect (see (c)).

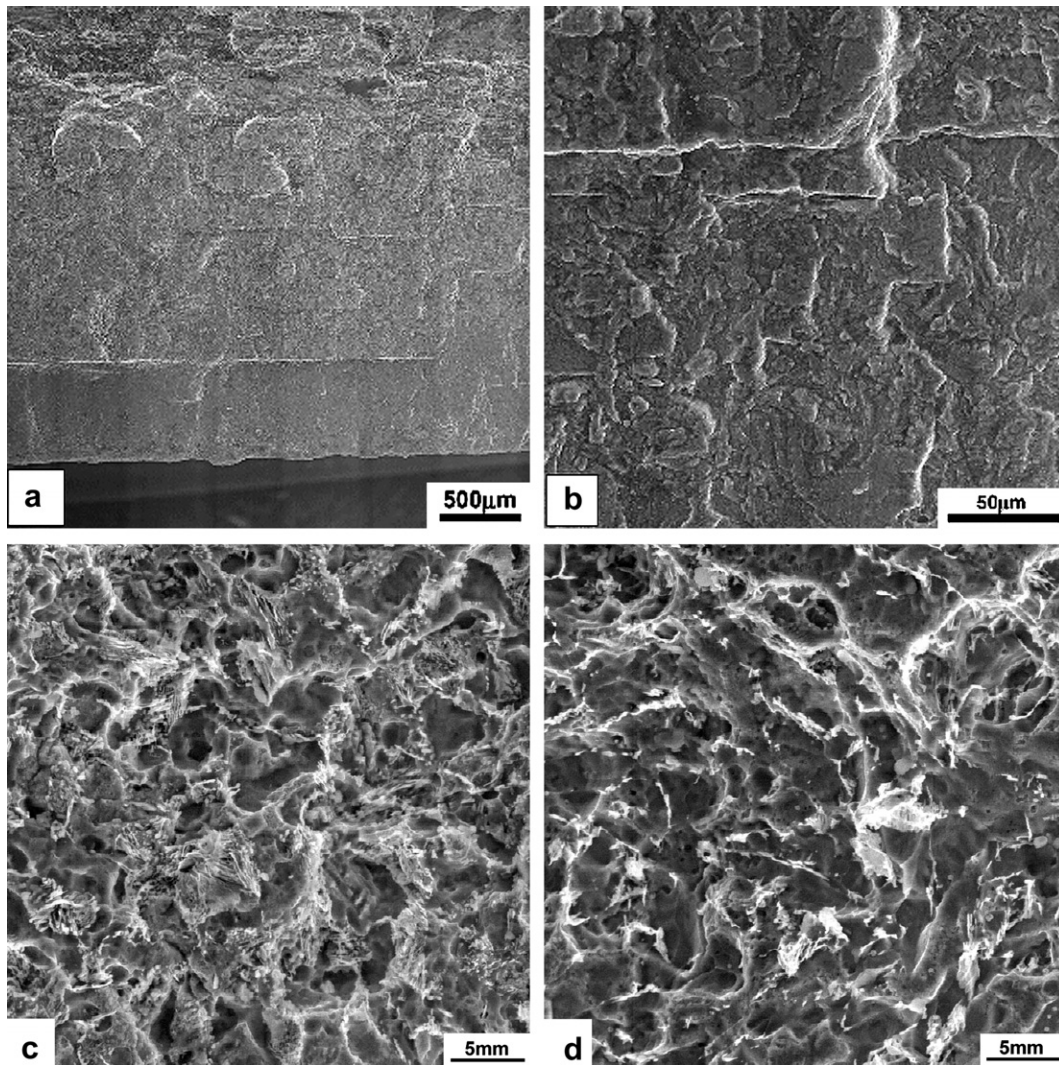
- a plane surface, until approximately 1.3 mm deep (inside HAZ region), with the presence of numerous parallel secondary cracks (see Fig. 6a and b);
- a rough surface topography inside the base metal region;
- a 45° rough surface (shear-lip) near the external surface of the tube.

A detailed examination taken between the parallel secondary cracks revealed that both HAZ and base metal regions featured predominately a ductile fracture mode (presence of dimples), see Fig. 6c and d.

Fig. 6. Microfractographic examination: (a) general view showing plane (bottom and central area) and rough (top area) regions and presence of parallel secondary cracks; (b) detail showing parallel secondary cracks; (c) detail inside the haz (plane surface) region showing predominance of ductile type fracture; (d) detail inside the base metal (rough surface) region showing predominance of ductile type fracture.

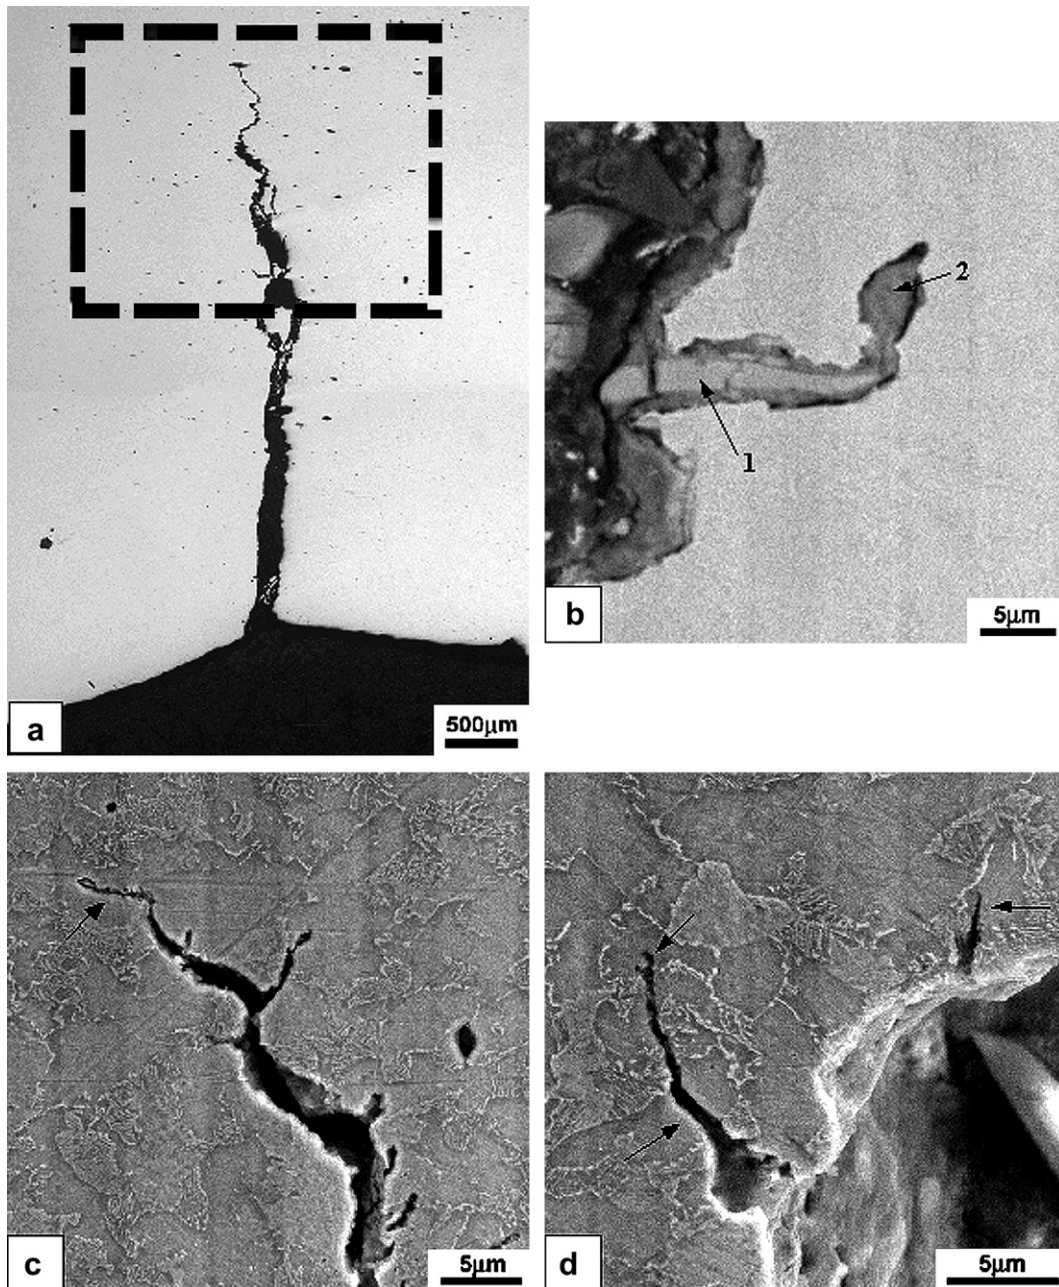
Microstructural examination of the primary crack propagation path (see Figs. 7a–9a) revealed that the crack nucleation took place in a superficial heterogeneity (150 μm deep welding defect), which was present at the welding/HAZ interface of the internal surface of the tube (see Fig. 9a), and progressed transgranularly perpendicular to the surface, featuring a moderate intergranular/transgranular branching along the HAZ region (see Fig. 7d). Preferential secondary cracking along the sulphide/matrix interfaces was also observed inside both HAZ and base metal regions (see Figs. 8b and 9b and c), originating the formation of parallel secondary cracks, which were observed during the microfractographic examination (see Figs. 6c, 8b and 9b and c). Within the metal base region, the crack propagation path presented a more intense branching, resulting in the formation of a rougher fracture surface (see Fig. 8c and d). Fig. 9d shows in detail the transgranular nature of the crack propagation inside the HAZ region and the presence of a deposit layer on the crack surface.

Fig. 8. Microstructural examination – crack propagation path – transversal section – nital etching: (a) general view; (b)–(d) detail inside the base metal region (see dotted area) showing more intense crack-branching (see arrows) and sulphide/matrix delamination associated with the presence of deposit layer, rich in Fe, O and S, on the crack surface (see arrows 1 and 2), SEM-BEI.

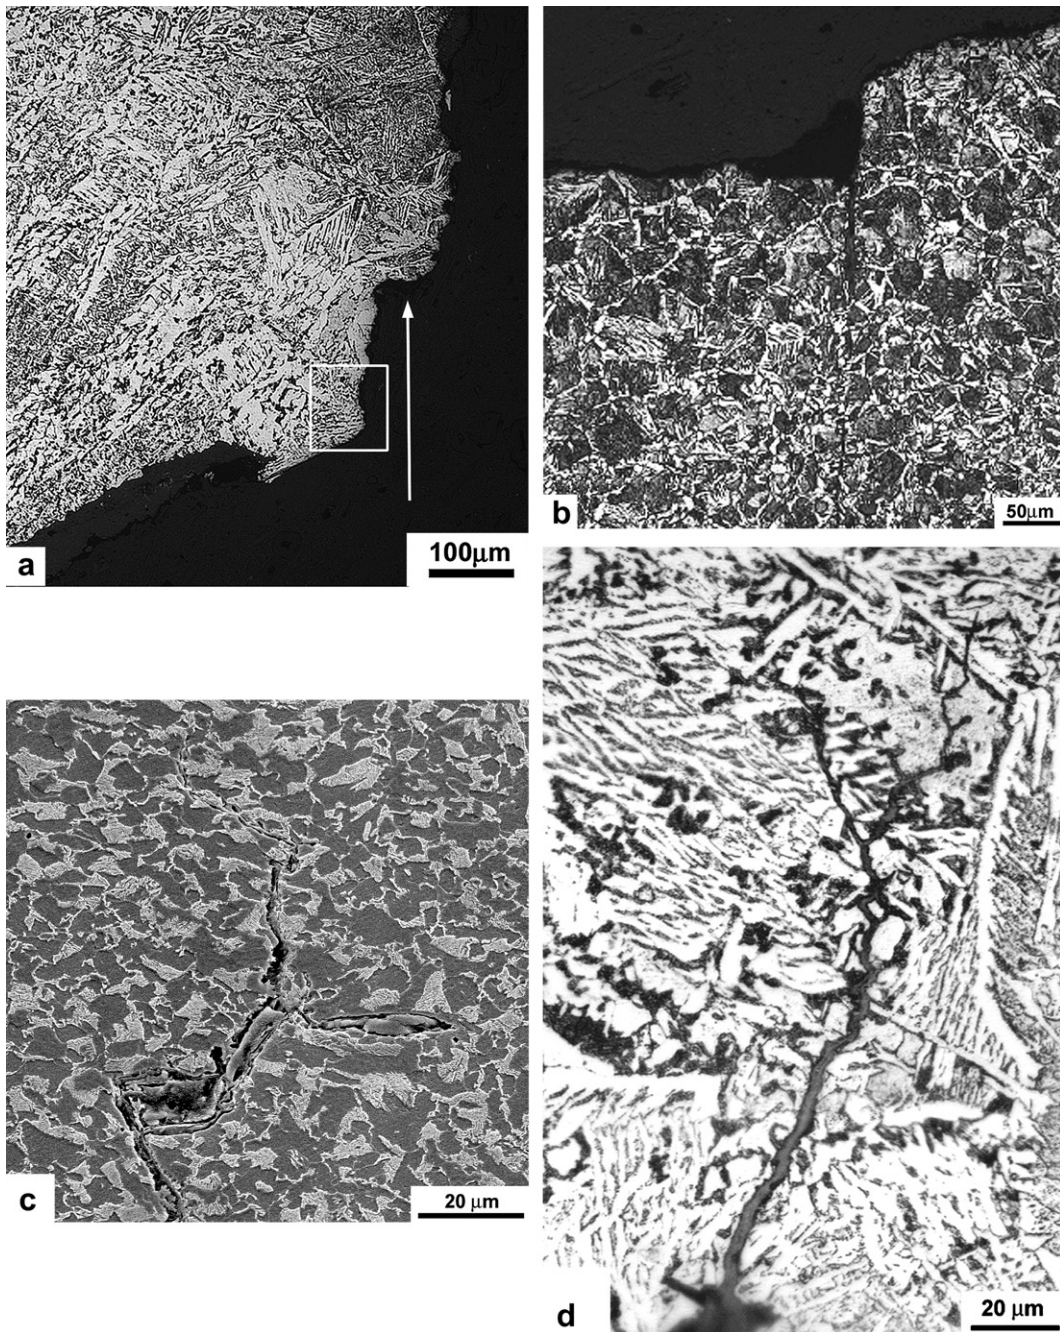
Fig. 9. Microstructural examination – crack propagation path – transversal section located in the middle of the elliptical fracture surface- nitral etching: (a) presence of a 150  $\mu\text{m}$  deep welding defect associated with the nucleation of the primary cracking, see arrow; (b) sulphide/matrix delamination inside the haz region; (c) sulphide/matrix delamination inside the base metal; (d) transversal cracking inside the haz region and presence of a deposit layer on the crack surface.

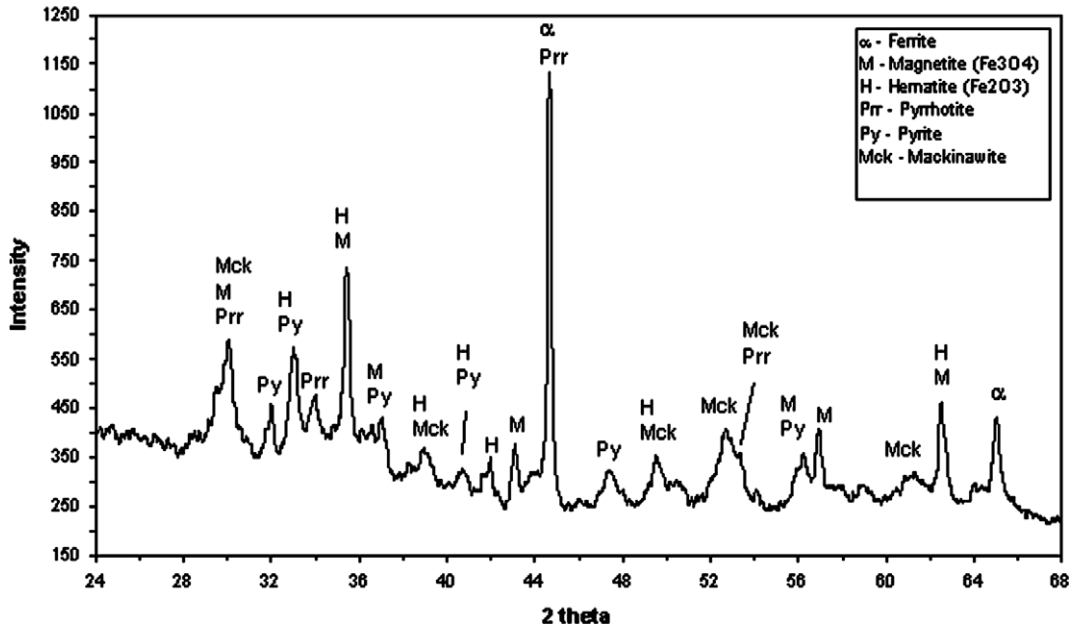
EDS microanalysis on the crack deposit layer indicated the presence of Fe, O, Si and S on many positions of the crack propagation (see Table 2), while the diffractometry results (Cu X-ray tube, voltage: 40 kV, current: 40 mA, scan mode: fixed time, sampling pitch: 0.01°, pre-set time: 8 s, scan range ( $\Delta 2\theta$ ): 24–68° conditions) on the deposit layer, which was present on the internal surface of the pipeline near the transversal cracking, revealed the presence of iron oxides ( $\text{Fe}_2\text{O}_3$  and  $\text{Fe}_3\text{O}_4$ ) and many types of iron sulphide (see Table 3 and Fig. 10), such as pyrrhotite, mackinawite and pyrite (multi-layered corrosion deposit). Finally, microhardness mapping (using Vickers hardness measurements – 4.9 N) of the welding region, as requested by ISO 15156-2:(2003) standard, is shown in Fig. 11a and b.

Fig. 10. Diffractometry results (Cu X-ray tube, voltage: 40 kV, current: 40 mA, scan mode: fixed time, sampling pitch: 0.01°, pre-set time: 8 s, scan range ( $\Delta 2\theta$ ): 24–68°) on the deposit layer, which was present on the internal surface of the pipeline near the transversal cracking.

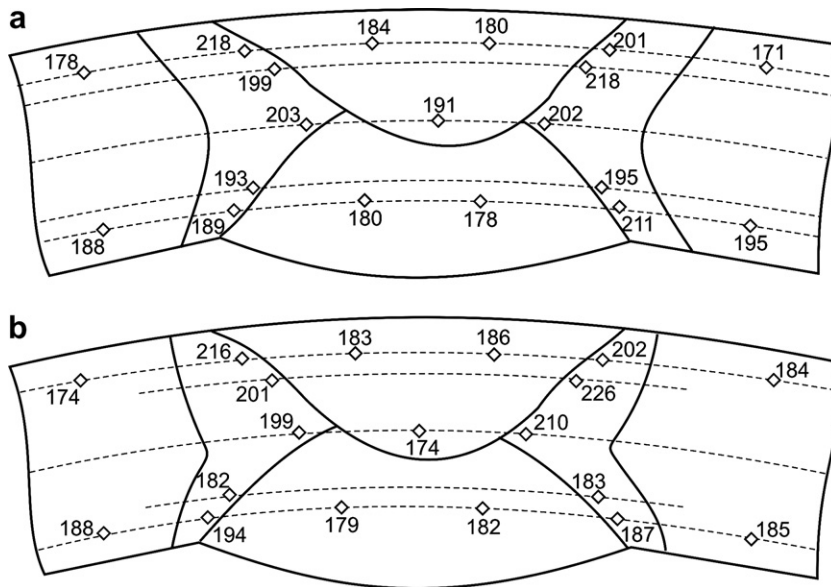
Fig. 11. Hardness mapping across two regions of the welding-transversal section.

According to DIN EN ISO 15156-2:2003 standard [15], however, the investigated API 5L X46 steel is not susceptible to sulphide-stress cracking under the pipeline working conditions (pH > 3,5 and H<sub>2</sub>S partial pressure > 0.3 kPa). Additionally, EN ISO 15156-1 standard [14] states that the hardness of welds, heat-affected zones and base metal of the pipeline play an important role in determining its sulphide stress cracking susceptibility, which is high in regions presenting hardness greater than 22 HRC or 249 HV (see Table 6). The results of hardness mapping (see Fig. 11a and b) confirmed that the investigated pipeline is not susceptible to sulphide-stress cracking mechanism.
