Defects and moisture problems in buildings from historical city centres: a case study in Portugal

Paulo B. Lourenço^{a,*}, Eduarda Luso^b, Manuela G. Almeida^a

Abstract

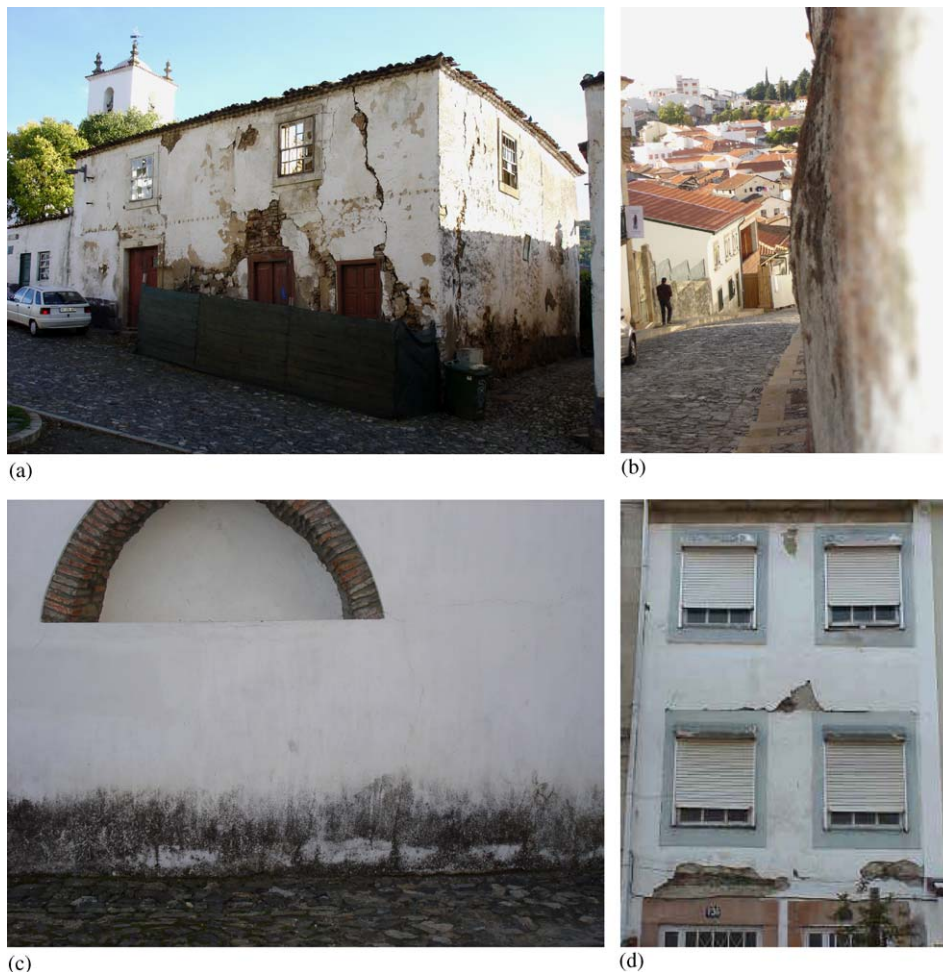
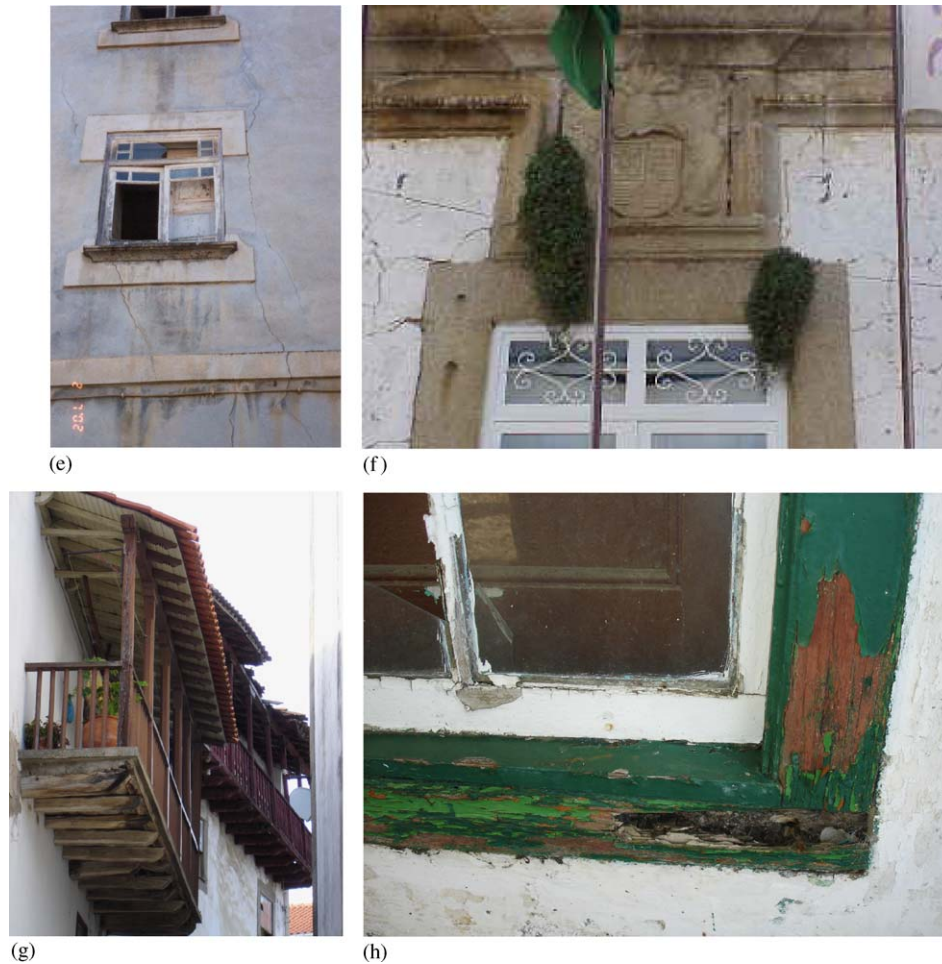
In the Citadel, 52% of the houses present wall strains at soil level, caused by rising humidity and rainwater splashing. It is stressed that 43% of the building do not exhibit gutters and 13% of the buildings have an incomplete downpipe [11], see also Fig. 9. The bulging damage of the walls occurs essentially in buildings with at least two floors, and the 25% value found indicates that detailed structural inspection and diagnostic of the Citadel is needed. It is also stressed that cracks with large width were found in the Citadel, confirming the presence of structural damage. Adequate recommendations for methodology and remedial measures in these cases have been recently published by ICOMOS [12].

Fig. 7. Example of damage: (a) collapsed structures, (b) bulging walls, (c) stains in walls at soil level, (d) detachment of rendering and painting, (e) cracks, (f) mould, fungus and vegetation, (g) roof deterioration, (h) timber deterioration in openings frames or balconies.

In conclusion, the water-related problems in the building envelope can be confirmed as the single most important defect. In the facades, it is possible to observe the existence of damage originated essentially by humidity, which appears in several forms, namely humidity caused by rain, by infiltration from the roof, by leaking connections and from rising damp. Humidity is both responsible for deterioration of the materials, namely rendering, painting, metal and wood, and for damage of the structure due to larger thrusts of the deteriorated timber elements and increased deformation of masonry elements.

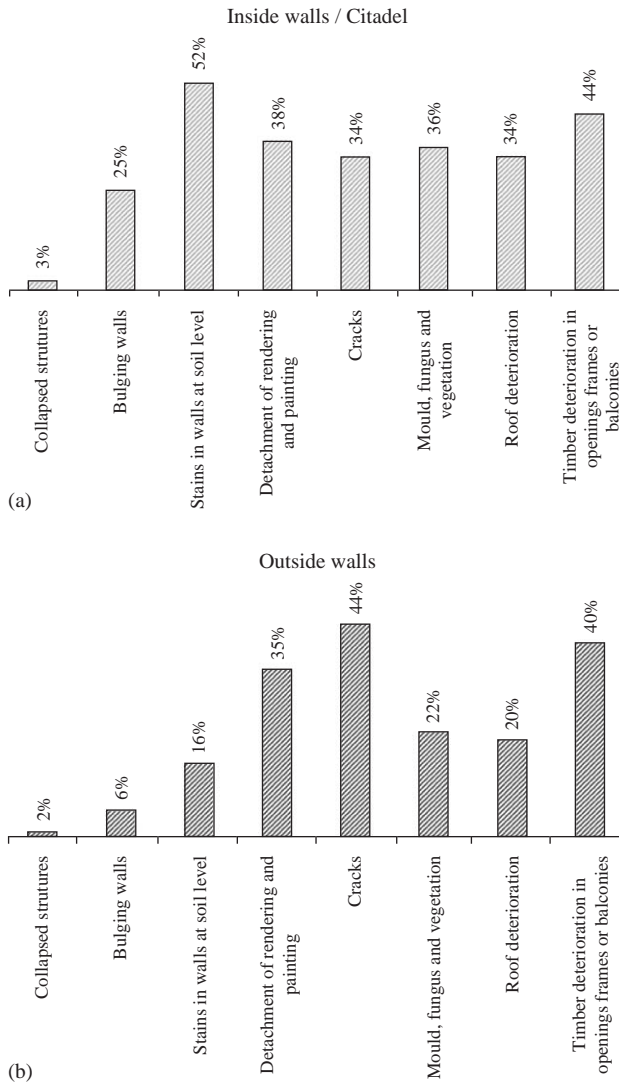
Three different areas from the historical centre were selected for analysis, namely the complete Citadel (inside walls), and two streets outside walls (Costa Grande Street and Direita Street), see Fig. 1. The results from the survey are given in Fig. 8. It can be observed that significant damage is present in the sample, in almost all non-structural items. This means that the presence of the different types of damage occurs simultaneously as a result of lack of maintenance. It is possible to see that in about 40% of the cases, cracking, deterioration of wood and deterioration of rendering, are present. In the structural items (collapse and bulging of walls), the situation is not severe, with the exception of out-of-plumb walls in the Citadel.

The damage in the Citadel is almost always larger than the damage outside the walls. This occurs due to the fact that the buildings in the Citadel are older, are of poorer construction and are more abandoned, meaning

that maintenance is less effective here. The sole exception is cracking damage, which is higher in buildings located outside the walls, due to the usage of new cement-based renderings. This is confirmed by the fact that the rendering and painting damage in the Citadel is similar to the walls outside; as this is not expected, it seems clear that incompatible materials are being adopted for the rendering and painting.

Fig. 8. Damage survey for the historical centre of Bragança: (a) inside walls and (b) outside walls.

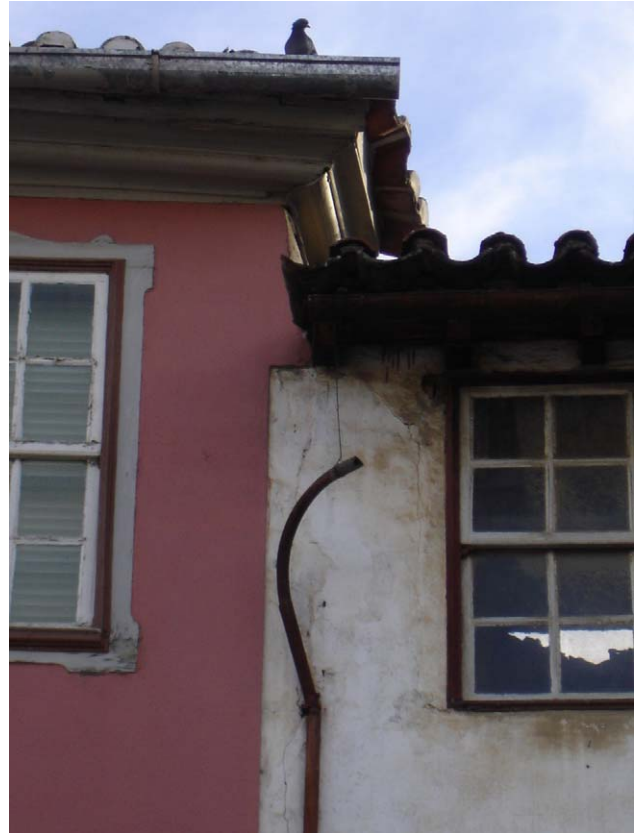
Fig. 9. Typical example of a defect in a downpipe.

- Roofs are very deteriorated, with broken tiles and severely damaged timber elements. Frequently, downpipes do not exist and, if present, they are normally obstructed, severely damaged or incomplete. In some cases, the windows and doors frames are also very deteriorated.

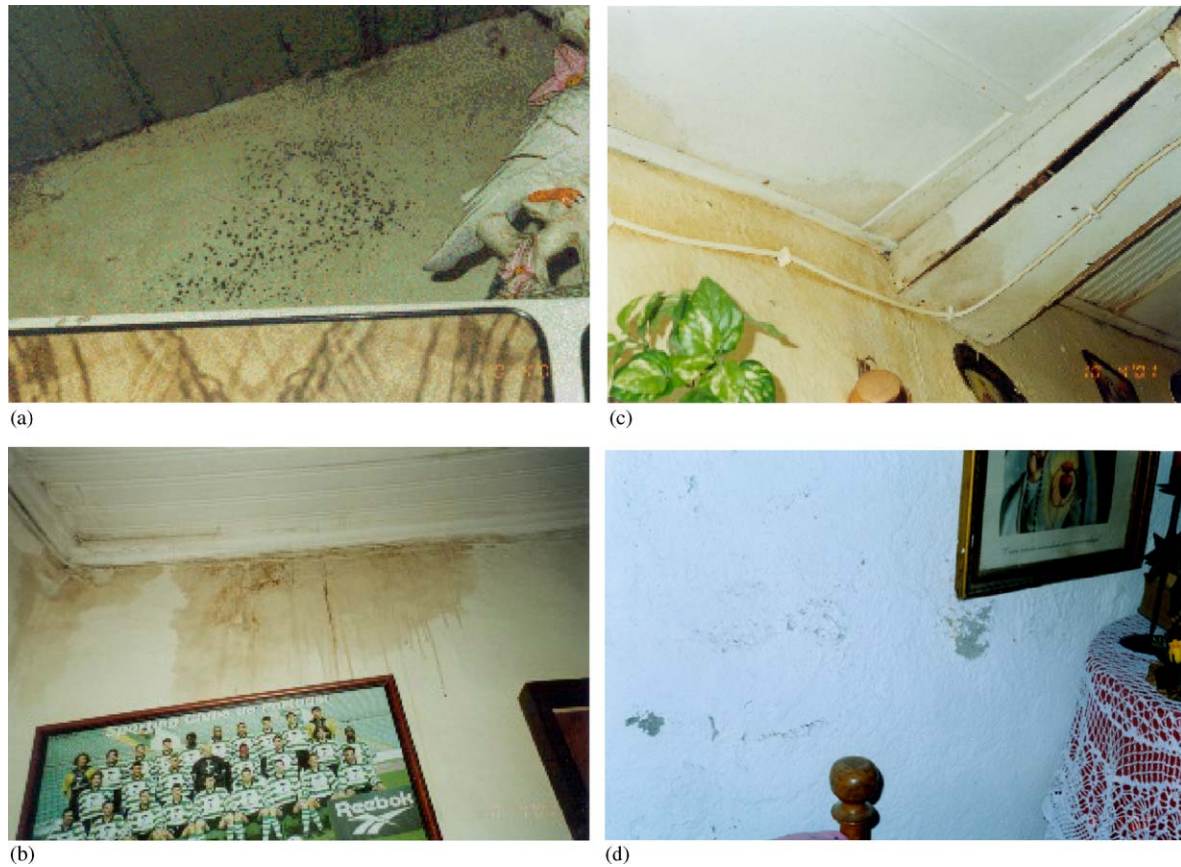
According to the survey, the most frequent defect is the emergence of pathological manifestations in the upper part of the walls that are in contact with the exterior or with a contiguous building. These moisture manifestations include stains, sometimes accompanied by mould. This type of biological colonization appears nearby the windows and doors frames, also corners or roofs, accompanied often by a strong odour.

Defects and deterioration of the roof is the major cause for water leakage and building pathology. Mould is usually associated with compartments with large production of water vapour, such as kitchens and toilets, but it occurs also in bedrooms and living rooms in the present case study. Condensations are also visible in coldest zones and non-ventilated places. In underground walls, deteriorated paintings, detachment of rendering and formation of efflorescence with high presence of salts were found.

Fig. 13. Examples of the damages observed inside the houses: (a) biologic activity, (b) stains due to humidity, (c) timber and roof deterioration, (d) detachment of rendering and painting and efflorescence with high presence of salts.

In the specific case of buildings in the Citadel of Bragança (oldest part), urgent repair is needed at many levels, with a special focus on: (a) construction of toilets, when absent, (b) repair or substitution of roofs, (c) conservation or substitution of renderings. Most of the existent pathological manifestations are caused by infiltrations of water through the roof or the facade and

by condensation phenomenon, creating unhealthy conditions for the occupants. The water infiltration can be avoided by the above remedial measures. The condensation phenomenon is related with the occupants' habits (punctual heating using gas equipments and drying clothes inside the house in the winter, which produces enormous quantities of vapour) and with the characteristics and poor quality of the envelope (lack of ventilation, reduced fenestration, reduced or inexistent solar gains and no thermal insulation). Repair measures must, therefore, also provide ventilation, thermal insulation and proper heating systems.
