Journal of Rock Mechanics and Geotechnical Engineering

Recent advances in high slope reinforcement in China: Case studies

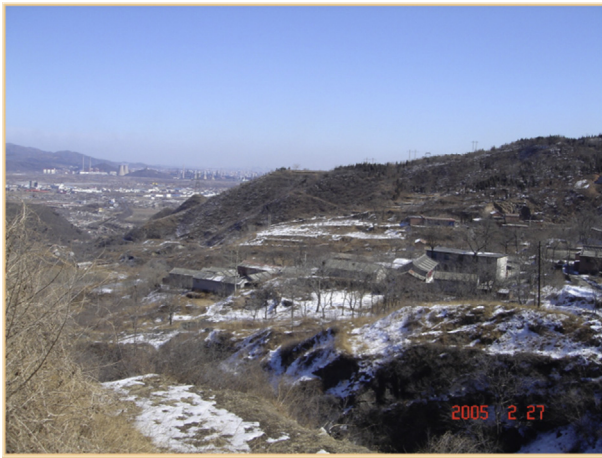
Fig. 1. Landslide in Jietai Temple.

Beijing, which has a history of over 1400 years. The Jietai Ordination Altar in the Temple, a national cultural relic, is the largest Buddhist Temple in China. It confers the highest commandment of Buddhism in history. The ridge of the mountain is 1200 m long from south to north and averagely 450 m wide from west to east. As a result of southward mining by 2 coal dykes at the depths of 122 m and 175 m in recent years, an opening was observed beneath the fourth level of the terrain. After a heavy rainfall on 20 July 2004, a penetrating fractured zone was formed in the temple yard on the ridge. Cracks were also observed in the yard of the temple, resulting in a rapid development of slope deformation, as shown in Fig. 1. Fig. 2 shows the damage of the buildings in Jietai Temple after landslide.

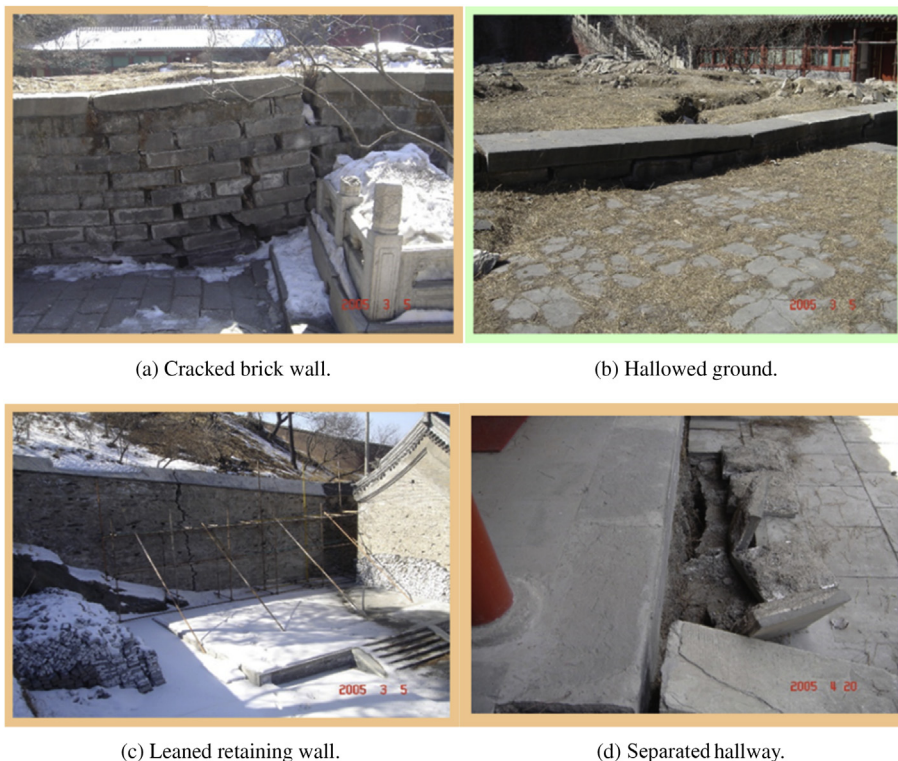
Fig. 2. Damage in Jietai Temple after landslide.

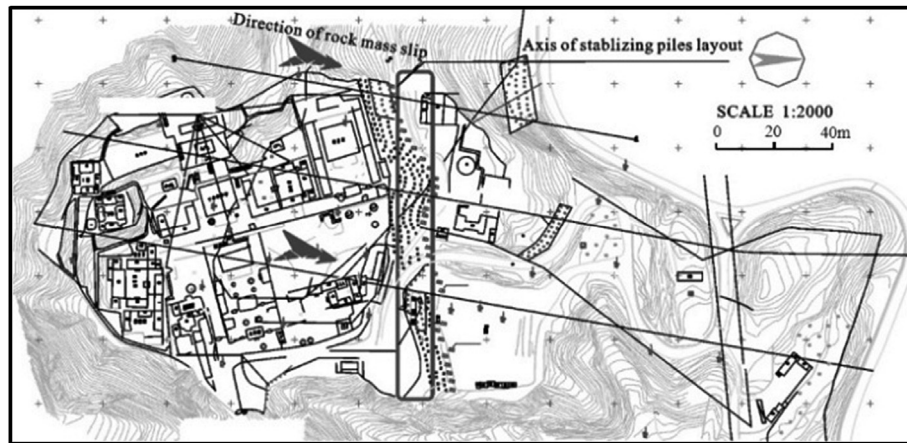
Fig. 3. Plan view of Jietai Temple landslide reinforcement.

Fig. 3 shows the plan view of Jietai Temple landslide reinforcement scheme. For this project, the key in the reinforcement scheme using multi-point anchored slope stabilizing piles is the excavation of slope stabilizing piles with multiple anchors at different depths

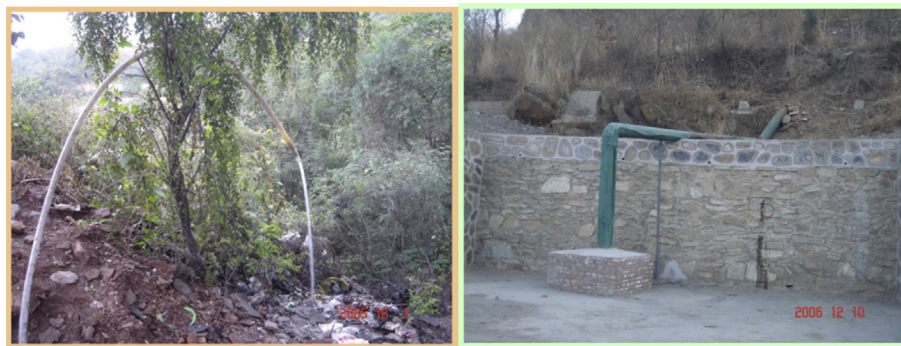
Fig. 6. Bottom drainage hole.

A tank was used below the bottom of slope stabilizing piles, and water pumps were employed to drain the water from deep soils, as shown in Fig. 6. Then, the pumped water from the tank can supply daily use and greening of the temple. This is an effective use of

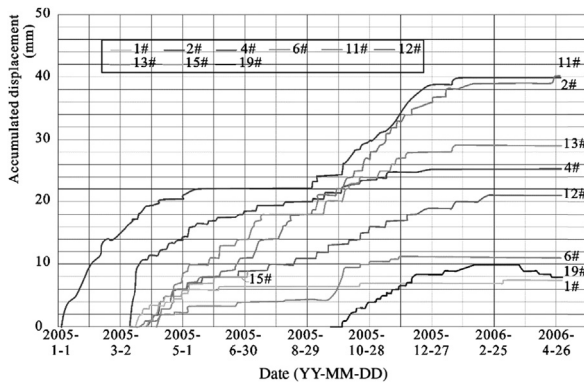
Fig. 7. Surface displacements of Jietai Temple landslide.

Fig. 7 shows the observed surface displacement of Jietai Temple landslide. It can be seen from this figure that the deformation of Jietai Temple landslide tended to convergence after the implementation of reinforcement measures. This indicates that the new reinforcement technology is effective in protection of this Buddhist shrine.

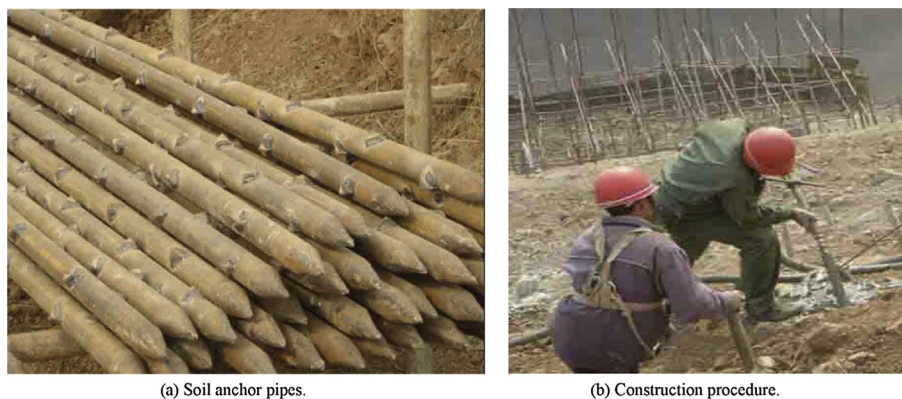
Fig. 10. Construction technology of soil anchor pipes.

direction, and the drop in elevation is 100 m, which is the largest reinforcement area of soil nailing works to date in China. The typical section of the reinforced slope is illustrated in Fig. 9. Pilot production is used to determine the material of the anchor pipes, concentration of grouting mortar, grouting pressure and related parameters of the soil anchor pipes (Fig. 10). The main parameters were determined as follows:

- (1) The soil anchor pipes is 6 m in length, 48 mm in diameter, and 3.5 mm in thickness, with conical contour guide heads on one end. Grouting holes with a diameter of 10 mm are installed in the middle of anchor pipes, and are drilled along the circumferential direction of the tube with an interval of 10 cm. Grouting holes are protected with triangle steel barbs.

- (2) Soil anchor pipes are rammed vertically into the slope at spacing of 1.5 m \times 1.5 m, which are arranged in the shape of quincunx.
- (3) Cement paste with water cement ratio of 0.65:1 is grouted into the anchor pipes at a grouting pressure of 0.4 MPa.

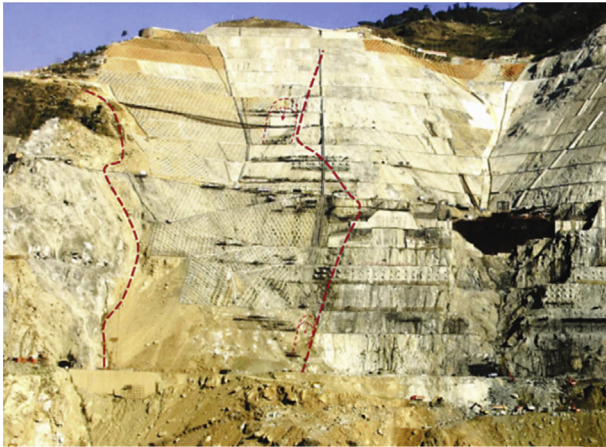
Fig. 12. Crack region of the alluvial deposit slope during excavation.

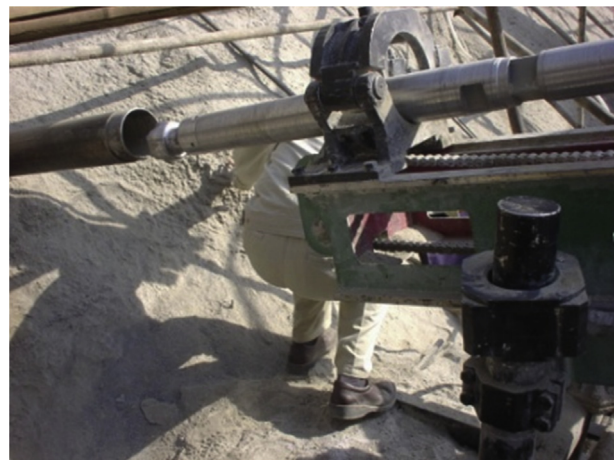
Fig. 16. Tube-drilling technique for installing cables in loose deposit body.

To prevent borehole collapse in the alluvial, a tube was followed simultaneously with drilling during pre-stressed cable construction. After drilling is completed, the eccentric head allows withdrawing of the rods, as shown in Fig. 16. Subsequent anchoring work can then be preceded. At the end of the anchoring, the steel casing will be pulled out.

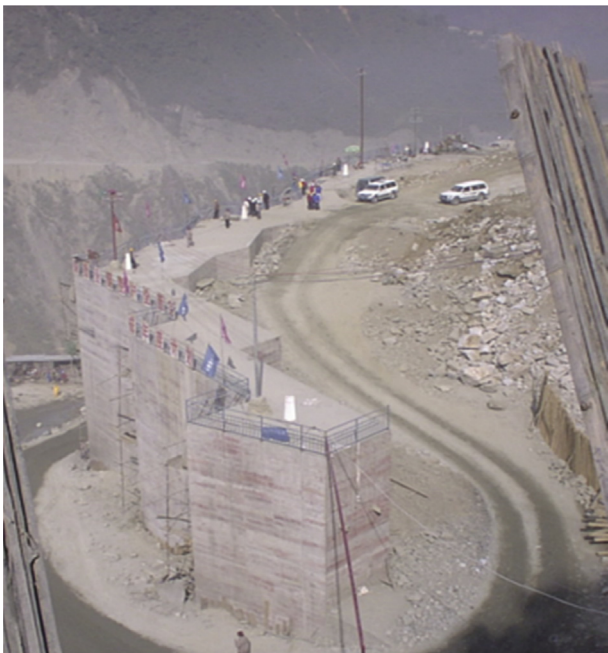
Fig. 17. The slope stabilizing retaining structure.

The slope stabilizing retaining structure contains ten $3 \text{ m} \times 5 \text{ m}$ and five $4 \text{ m} \times 7 \text{ m}$ cantilever stabilizing piles, which are installed at the elevation of 1245 m. The depth of the piles in the south is 40 m approximately, and about 40–60 m in the north. Another two-row slope stabilizing piles were arranged at the berm at elevation of 1310 m. Fig. 17 shows the slope stabilizing retaining structure after implementation of stabilizing piles.

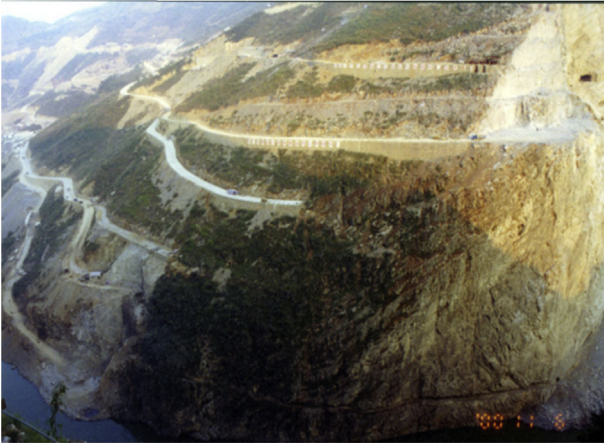
Fig. 18. Left bank high slope of Hongjiadu hydropower station.

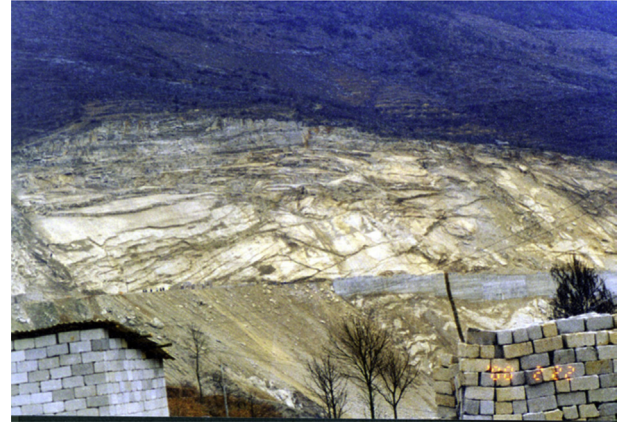
Fig. 20. The bedding landslide occurrence during road excavation.

The left bank intake structures are located at the bottom layer of limestone. Several intercalated layers named J₁–J₈ (Fig. 19) were developed. Landslide would most likely take place during construction. Fig. 20 shows a case of landslide triggered during a road excavation (Deng et al., 2007).

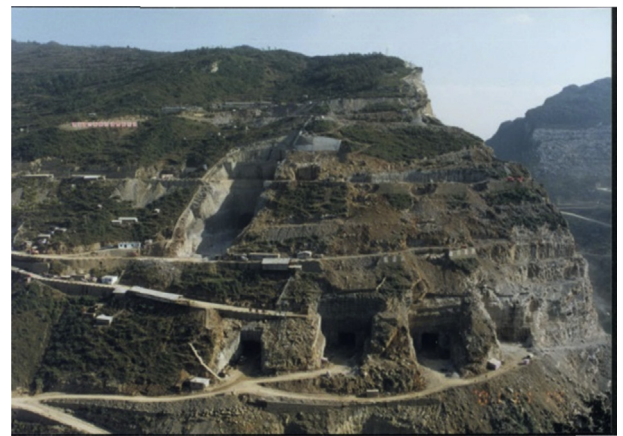
Fig. 21. Excavation of the portals on the left bank.

Each intake has been excavated with opening of its own limits (Fig. 21). The stability of the intake slopes at normal situation was evaluated to be a limit state by 2D limit equilibrium analysis. Using 3D limit equilibrium method, the stability of the intake slopes can be significantly increased by 30% (Yang et al., 2008a). It should be noticed that the overall stability of the left bank slope cannot satisfy the requirement of design. Therefore, it is necessary to adopt the reinforcement measures to ensure the overall stability of the slope.

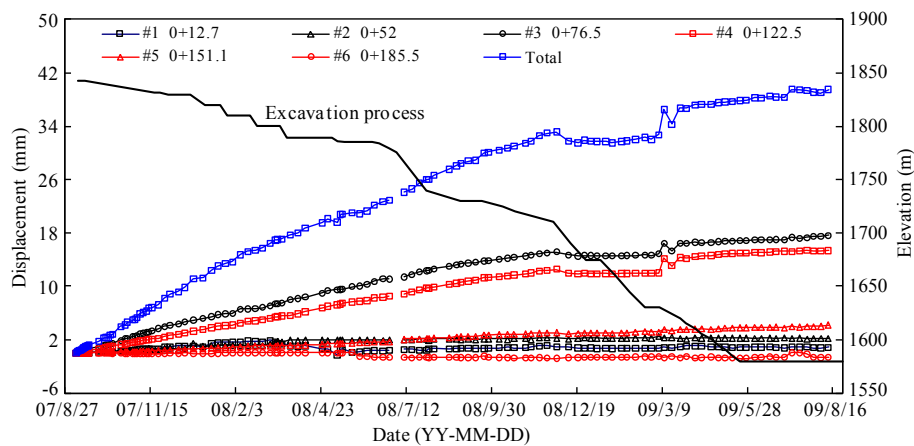
Fig. 30. Variations of displacements of measuring points of G44 with excavation process.

completed. In order to understand the deformation of deep-seated tensile cracks located in the deeper part of the left bank slope, the graphite rod extensometer (G44) was installed in PD44 at the elevation of 1930 m. Fig. 30 shows the variation of deformation of G44 with elapsed time. The deformation monitoring results indicate that the high rock slope is stable and safe after implementation of slope excavation and reinforcement.
