Numerical investigation into the failure of a micropile retaining wall

Pere C. Prat*

Dept. of Civil and Environmental Engineering, UPC-BarcelonaTECH, Spain

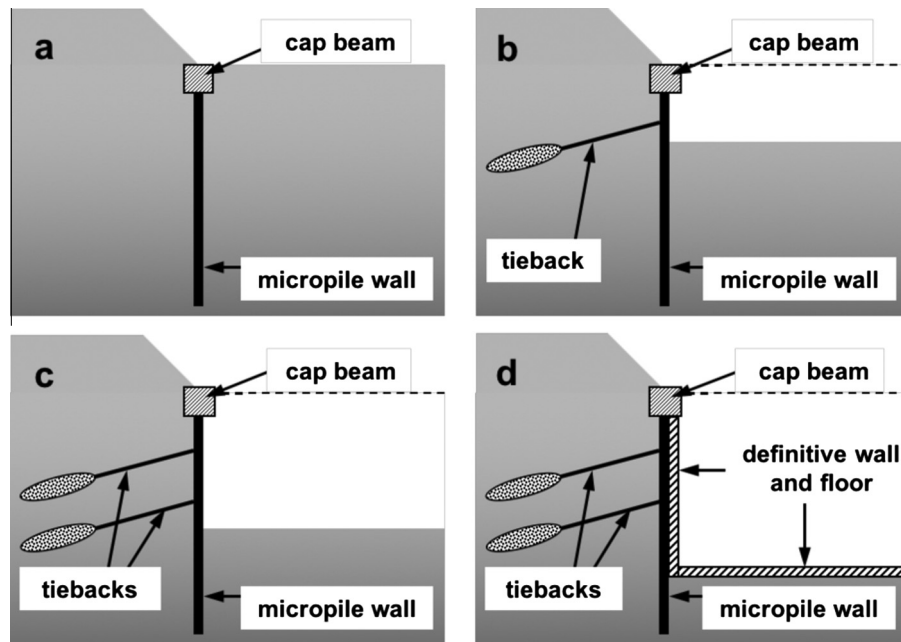
Fig. 1. Schematic sequence of the excavation: (a) execution of the micropiles; (b) and (c) intermediate stages including excavation and execution of the tiebacks; (d) final state.

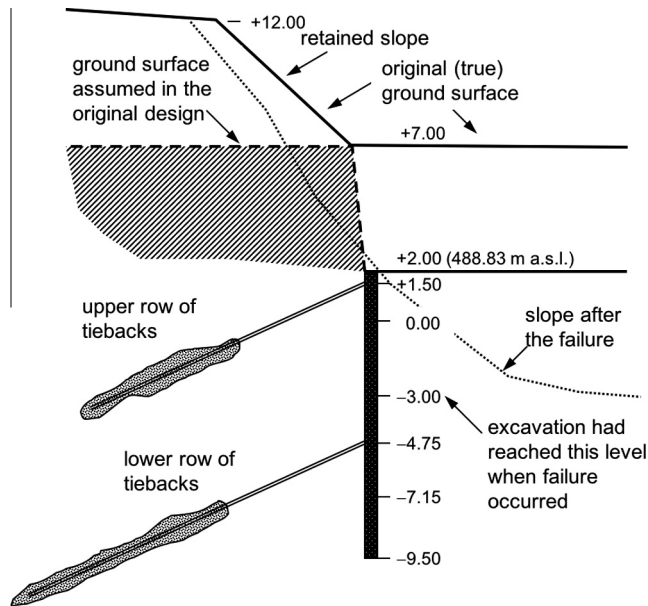
Fig. 5. Typical cross-section used in the analysis (AA' in Fig. 2).

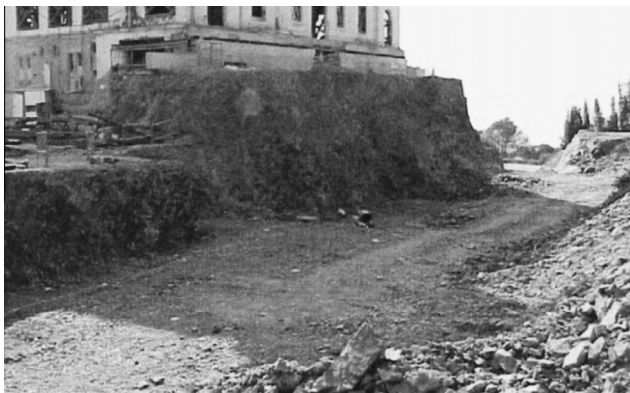
Fig. 6. View of the excavation zone before the wall was initiated. The location of the failure is on the right of the image.

Fig. 6 shows a picture of the area where the excavation was being made and where the collapse occurred (at the right of the picture). Fig. 7 shows a general view of the failure area. An intact portion of the wall with the cap beam can be seen on the left of

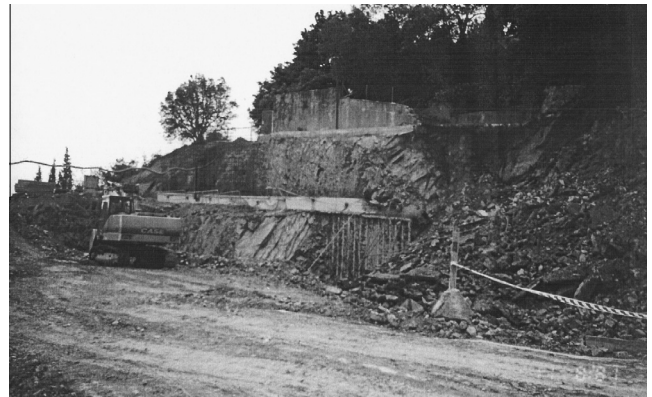
Fig. 7. View of the collapsed wall. The intact part of the wall with the cap beam can be seen on the left, and the failed part on the right.

the picture. The failed portion is at the right of the image where the new slope created by the sliding ground is clearly visible. Fig. 8 shows a partial view of the failed zone where parts of the broken piles and cap beam can be seen scattered on the ground surface. The conditions of the zone immediately after the failure were not preserved intact after it occurred, because swift action was taken by the contractor to clean the area. Therefore, there was only limited graphic documentation. However, verbal description given by the personnel working in the construction site suggested that most of the tiebacks failed due to excessive tension, while some were pulled out with the wall as it moved laterally with a rotation and translation motion.

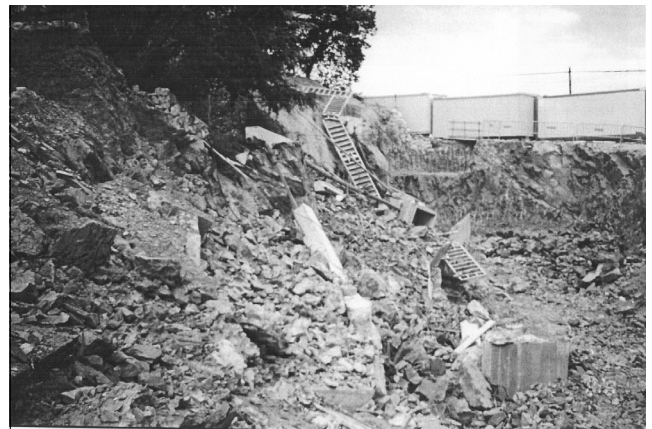
Fig. 8. Detail of the failed wall. Parts of the broken piles and cap beam can be seen scattered on the ground surface.

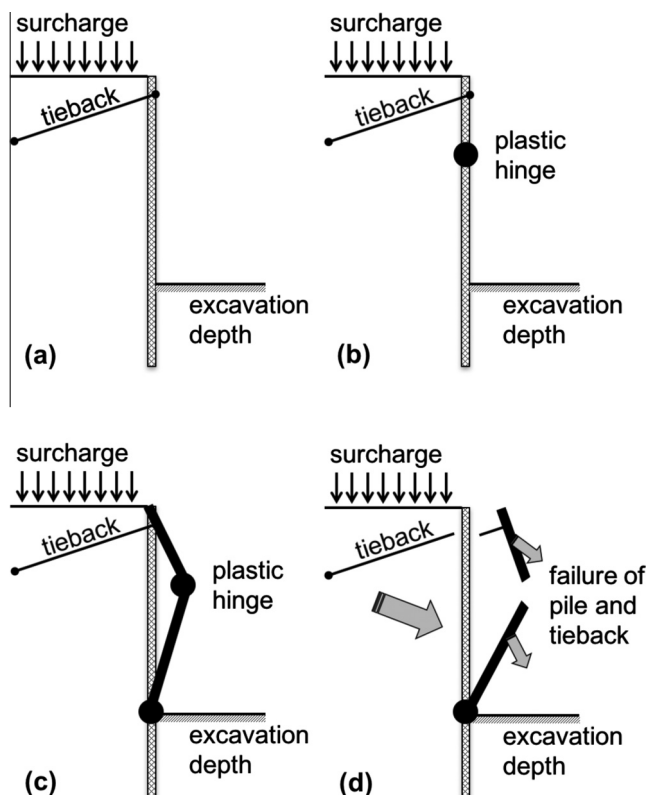
Fig. 9. Collapse mechanism: (a) initial conditions; (b) a plastic hinge forms, arching occurs behind the wall and the ground cannot resist; (c) lateral deformation of the pile begins with the tieback within its strength limit; (d) large lateral deformation and failure of the tieback and pile.

With this limited preliminary information, the most likely failure mechanism is illustrated in Fig. 9, in which it is assumed, as suggested from a simple analysis using Blum's method [33], that when a plastic hinge develops in the micropile because the bending moment exceeds its bending strength, the load on the tieback is still less than its yield limit. Step (a) in this figure shows the initial condition in which the back slope surcharge acts as a load without contributing to the strength. With this conditions, when the bending moment on the micropile exceeds the yield moment, step (b), a plastic hinge forms, releasing the confinement of the earth behind the retaining wall so that the earth pressure is applied only to the less deformable elements: the tieback and the embedment. At this time the ground behind the wall has failed and has no apparent cohesion. The earth pressure is then transferred mostly to the tieback thus increasing its load until it reaches the yield limit of the steel cables, step (c). After that, failure of the tiebacks and of the micropile happens immediately, step (d), with the consequent collapse and sliding of the ground towards the existing excavation surface.

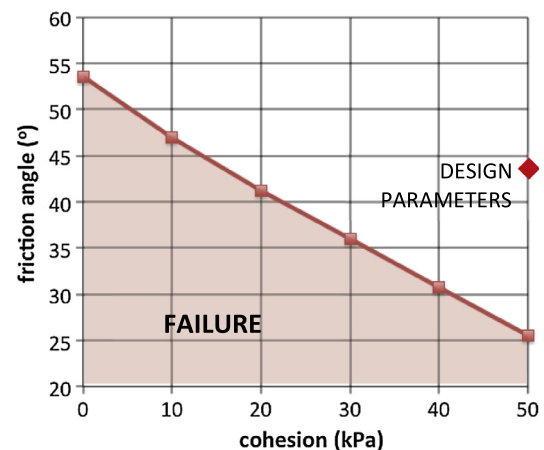
Fig. 10. Limiting envelope of strength parameters combinations leading to failure.

Therefore, the actual back slope height of 10 m and dry soil (because water did not play a significant role) have been adopted to analyse the failure with the 36 (c' , ϕ') pairs with ranges defined in Table 1. Fig. 10 shows the limiting envelope of these (c' , ϕ') pairs considered in the failure analysis. Pairs outside the shaded area do not lead to failure and therefore cannot be the actual strength parameters since failure did happen. This shows that the design strength was largely overestimated, since the (c' , ϕ') pair used in the design is well outside the shaded area. The results suggest that the strength parameter sets that most likely represent the *in situ* conditions are H3 or H9 (Table 1), with $c' = 0$ or 10 kPa respectively, both with $\phi' = 30^\circ$.

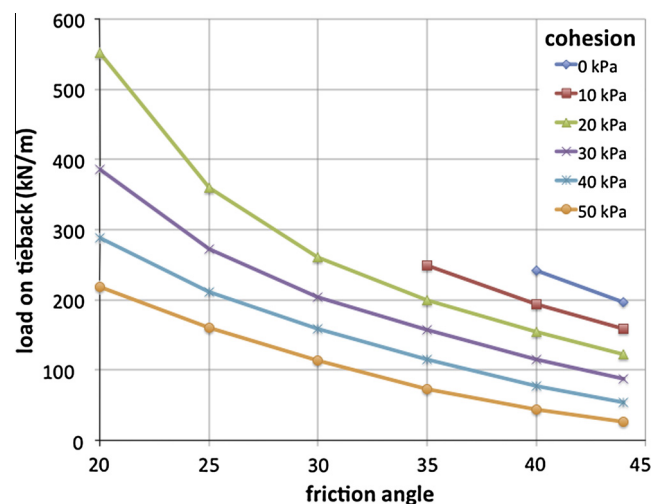
Fig. 11. Predicted load on the upper tieback row at the end of construction for all strength parameters combinations analyzed. Missing points indicate failure before reaching this stage.

The failure conditions of the tiebacks were also analysed. The tiebacks were made of steel cable with a load capacity of 150 kN per cable. Each tieback on the upper row consisted of two cables, with a total load capacity of 300 kN. With a separation of 3 m, the total admissible force on the tiebacks, per unit length, was 100 kN/m. Fig. 11 shows the predicted load on the upper tieback row at the end of the construction for each (c' , ϕ') pair in Table 1, with the C1 load setup. This figure shows how the load is higher with lower strength parameters, since then the lateral pressure on the wall is much larger. The figure shows also that there are only six (c' , ϕ') pairs for which the load on the tiebacks remains below 100 kN/m during all construction steps, including those that were never executed because the wall failed before: H24 (30 kPa, 44°), H29 (40 kPa, 40°), H30 (40 kPa, 44°), H34 (50 kPa, 35°), H35 (50 kPa, 40°) and H36 (50 kPa, 44°).

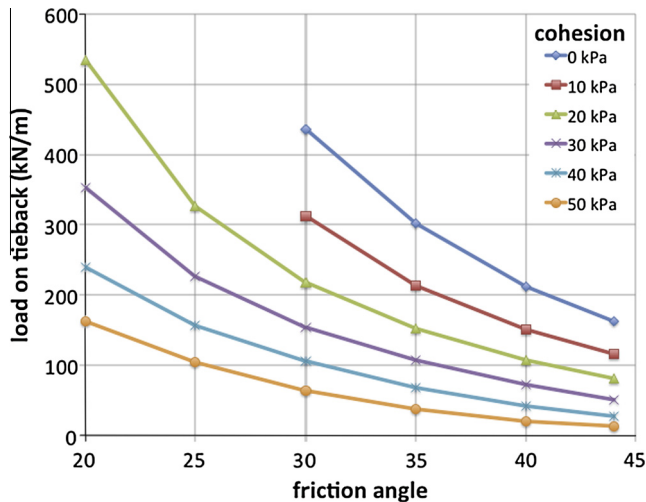
Fig. 12. Predicted load on the upper tieback row at the end of construction stage 5 when the actual collapse occurred. Missing points indicate failure before reaching this stage.

Fig. 12 shows the value of the load on the same row of tiebacks at the end of step 5, which was the last actually executed and dur-

ing which failure occurred. Note that for some of the (c', ϕ') pairs failure happens before reaching this step. Considering only the construction steps that were actually executed before failure (step 5), the load on the tiebacks remains less than 100 kN/m with four more (c', ϕ') pairs: H18 (20 kPa, 44°), H23 (30 kPa, 40°), H28 (40 kPa, 35°) and H33 (50 kPa, 30°). These latter (c', ϕ') pairs are outside the range considered most likely. Therefore, since for the remaining (c', ϕ') pairs the load on the tiebacks is larger than the maximum admissible, it may be concluded that at the time of failure the load on the tiebacks was larger than its yield strength, and the cables were fully in the plastic regime.

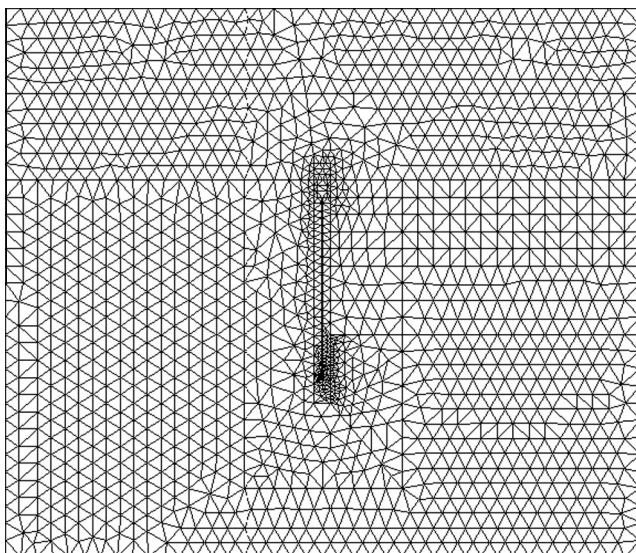
Fig. 13. Initial (step 1) finite element mesh used with DRAC.

analysis, a 2D finite element model in plane strain has been developed (Fig. 13).

The numerical model is made of 1809 nodes, with 3261 triangular and 33 quadrilateral linear elements to simulate the rock mass, 73 interface elements to simulate the contact between the micropile wall and the ground, and two rod elements to simulate the two rows of tiebacks. The mesh is denser near the micropile wall, where failure is expected to occur. The rock mass is modelled with a Mohr-Coulomb material law, with the cohesion and friction angle corresponding to each of the (c', φ') pairs in Table 1. The rest of the material parameters are given in Table 2. For simplicity, and because lack of actual data, K_0 prior to excavation has been assumed to be 0.5 in all cases.

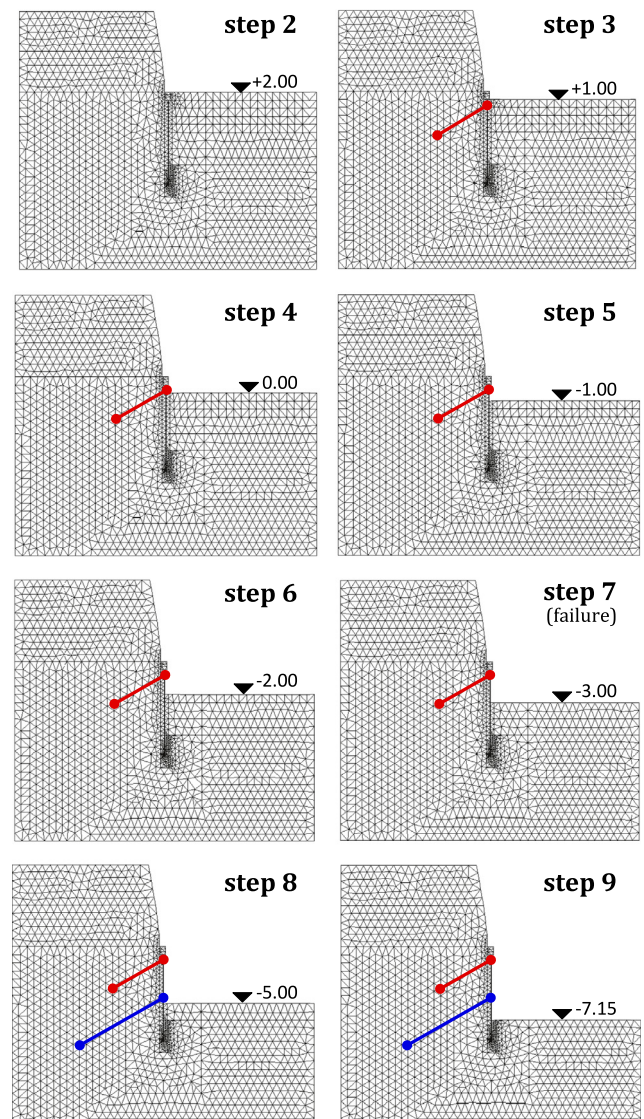
Fig. 14. Excavation sequence with DRAC (step numbers refer to the numerical analysis, not to the construction sequence).

The sequence of excavation and construction of the micropiles and tiebacks has been simulated in 8 numerical steps, graphically described in Fig. 14, with the C1 load setup. The numerical steps do not necessarily coincide with the construction steps defined previously. Thus, numerical step 1 (Fig. 13) is the generation of the whole finite element mesh and the assigning of the initial stresses at the integration points. Although failure occurred when excavation reached the depth corresponding to numerical step 7, the analysis has been carried out to the end of the described

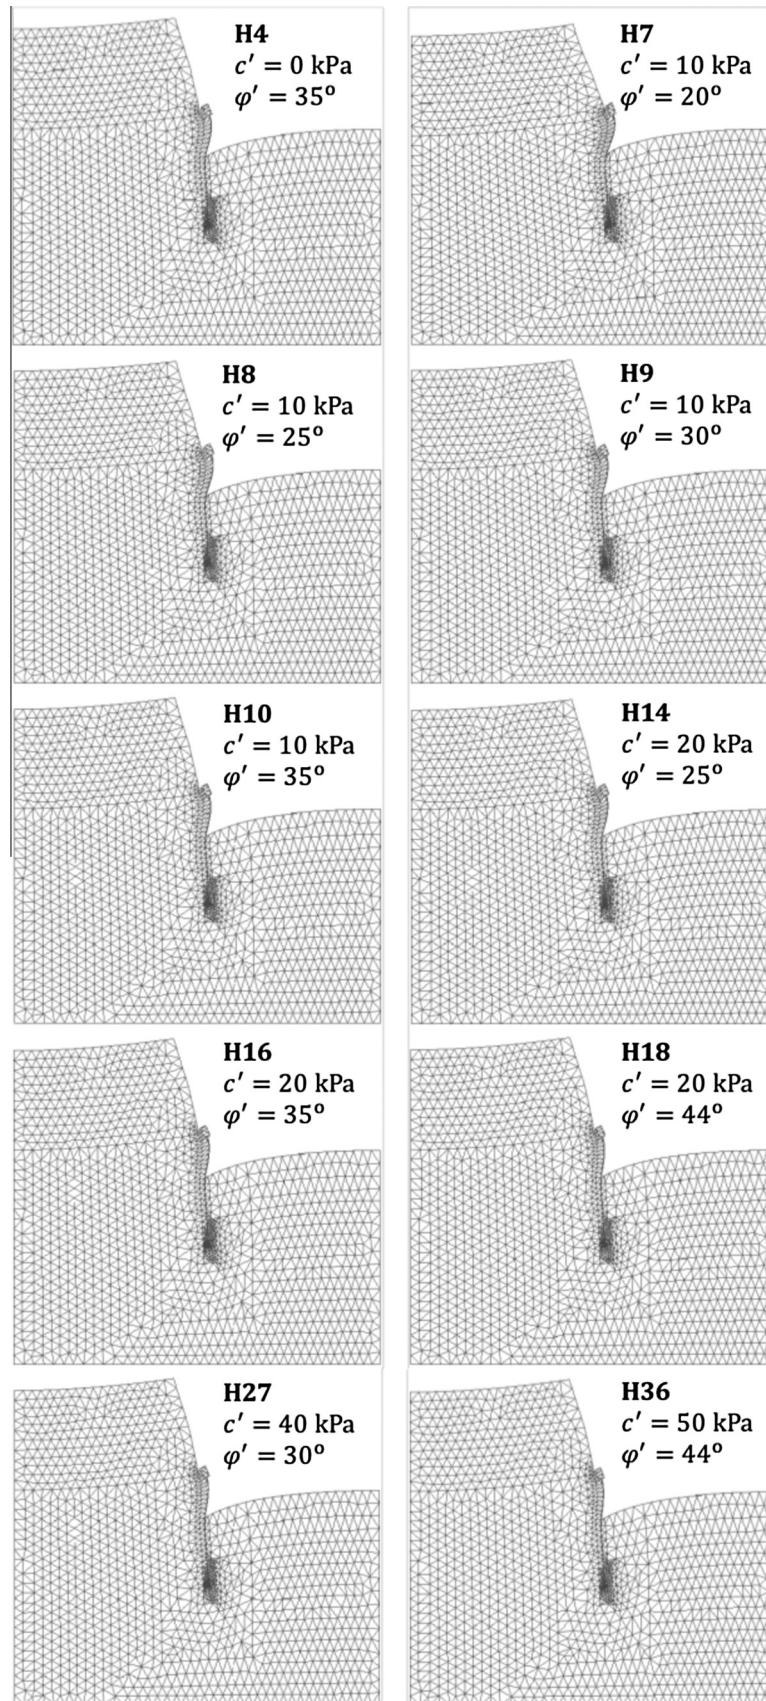
Fig. 16. Deformed mesh obtained with DRAC near the micropile wall after step 7 for the selected sets of strength parameters indicated (magnification: 100×).

In general, the results obtained from the finite element analysis with DRAC are in good agreement with the results from the analysis with PARATIE™. Especially illustrative are the results showing the plastic deformation contours (Fig. 15), which can be used to locate the position of the failure surface, and the deformed mesh (Fig. 16), showing the curvature of the deformed micropile wall, a qualitative measure of the existing bending moments. High values of plastic deformation indicate the zones where the material has reached its yield limit. When this zone with high plastic deformation extends to a large volume, it indicates that the material has reached a global collapse condition. Fig. 15 shows the extent of the plastic zone at the end of numerical step 7 for some selected (c', φ') pairs. The figure shows that for low values of cohesion and friction angle, the volume of the plastic zone is large indicating that the ground behind the micropile wall has failed completely, whereas this volume decreases when the values of these parameters increase. In particular, for the values of c' and φ' used in the original design of the retaining wall ($c' = 50$ kPa and $\varphi' = 44^\circ$, respectively, set H36) no significant plastic zone develops during excavation.
