# Experimental and numerical study on collapse of aged jacket platforms caused by corrosion or fatigue cracking

Chun Yan Ji, Hong Zhi Xue, Xing Hua Shi<sup>\*</sup>, Oleg Gaidai

School of Naval Architecture and Ocean Engineering, Jiangsu University of Science and Technology, Zhenjiang, Jiangsu Province, PR China

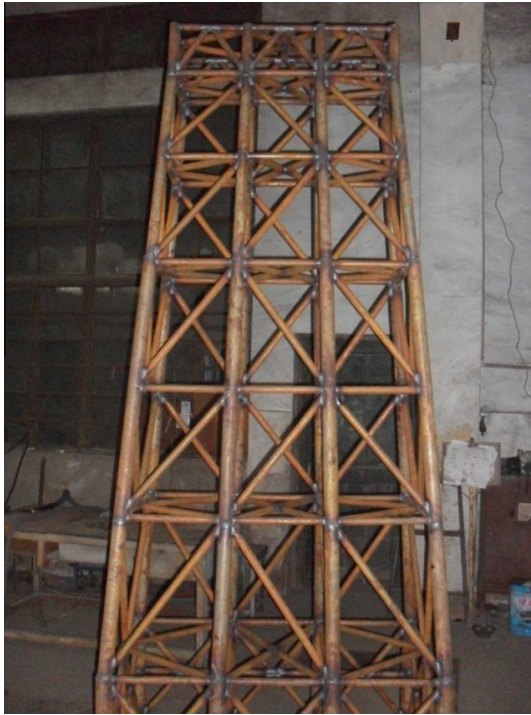
Fig. 5. The corrosion model of jacket.

The corrosion model shown in Fig. 5, has reduced thickness compared with the intact model. The corrosion in this tested model is induced via an electrochemical approach in which the corroded thickness can be achieved through the electrochemical time accurately in the laboratory. The corrosion model parameters and the damage value are shown in Table 5. Scantling and material are the same as for the intact tested model. The corrosion loss is 0.28 mm for submerged elements and 0.16 mm for atmospheric ones for the jackets serving 50 years, as shown in Table 2.

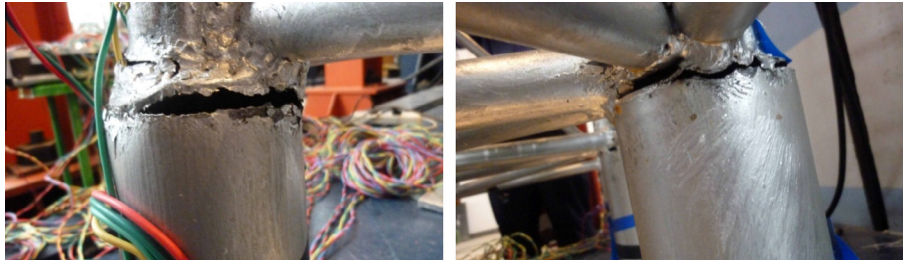
Fig. 13. Crack tearing deformation of the corrosion model.

resistance of 33.4 kN. After that, the unloading begins. From the point A to the point B in Fig. 12, the resistance of the model degrades significantly, while the appearance and propagation of the cracks is observed in the legs under tension in this stage. From the point B to the point C, the resistance decreases slowly, while the horizontal displacement of the test model increases rapidly. Cracks were observed to propagate rapidly as well, resulting in large deformation of the leg damaged circumference under compression, as shown in Fig. 13. The whole structure failed as the resistance degraded seriously, between points C and D. The failure mode is the tearing failure of the leg. The larger reduction of the pipe thickness is changing the failure mode of the platform, meaning that failure mode of platform can vary from being either the local structure tearing mode, or the global yield mode. The main

reason is that the stress increases and rearranges in the whole structure due to the thickness lose, especially in the joints of the legs and the braces, and with the increasing of the load, the high stress areas appear near the cracks. Rapid crack propagation caused the corroded model failure due to local tearing.

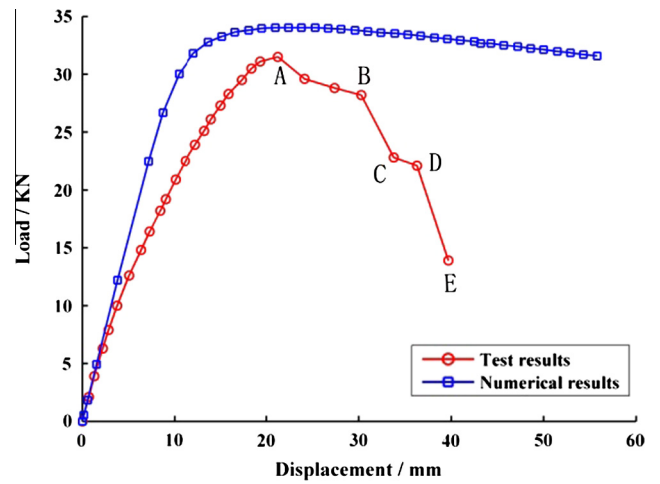
Fig. 16. Comparison between the test and the numerical results of the crack model.

Series of FEM analyses were performed to simulate the ultimate state of intact and damaged jacket with cracks or corrosion. Results are shown in Figs. 14–16. Comparison between test and numerical load–displacement curves for three jackets models studied in this paper is shown in Fig. 17. Comparison results show that the

stiffness of the platform model, obtained by numerical calculation is larger than the stiffness obtained by the test, before the model reaches its maximum resistance. This is mainly caused by ignoring the initial imperfections of the jacket models in the FE model by the numerical method, such as imprecise of machining (initial deformation and residual stress induced by manufacturing) and some uncertainty of material properties. Numerical FEM method presented in this paper can give good estimation results which are agreed with experiments for the ultimate strength of a steel jacket platform with corrosion or fatigue crack. The ultimate strength numerical and experimental results for the intact, crack and corroded jacket models are listed in Table 6. The relative deviations between numerical and experimental results are about 2.71%, 7.25% for intact and corroded model, and about 8% for the crack model.

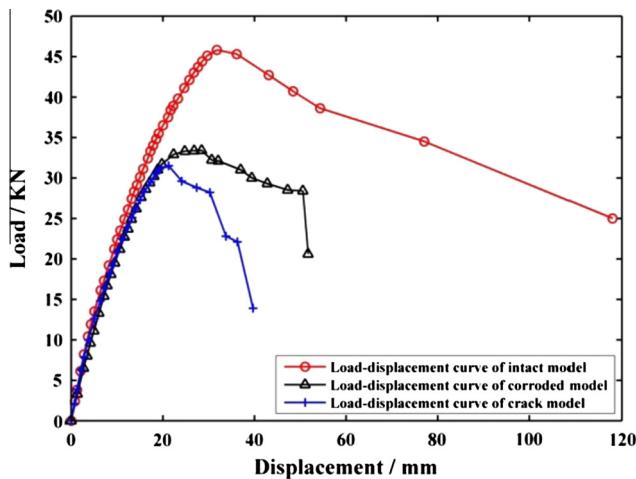
Fig. 18. Comparison between intact, corroded and crack models.

Fig. 18 shows a comparison of the load and displacement relationships between the intact, corrosion and crack model. Comparison shows that stiffness of the crack model and the cor-

roded model is slightly less than that of the intact model before reaching the maximum bearing capacity. The ultimate strength of the crack model and the corroded model is significantly less than that of the intact model. The degradation of the crack model is more than 30% compared with the intact one, about 27% for the corrosion model. The latter indicates the corrosion and crack will significantly decrease the ultimate bearing capacity for an aged
