Geosynthetics with Enhanced Lateral Drainage Capabilities in Roadway Systems

Jorge G. Zornberg, Marcelo Azevedo, Mark Sikkema, Brett Odgers

To appear in: *Transportation Geotechnics*

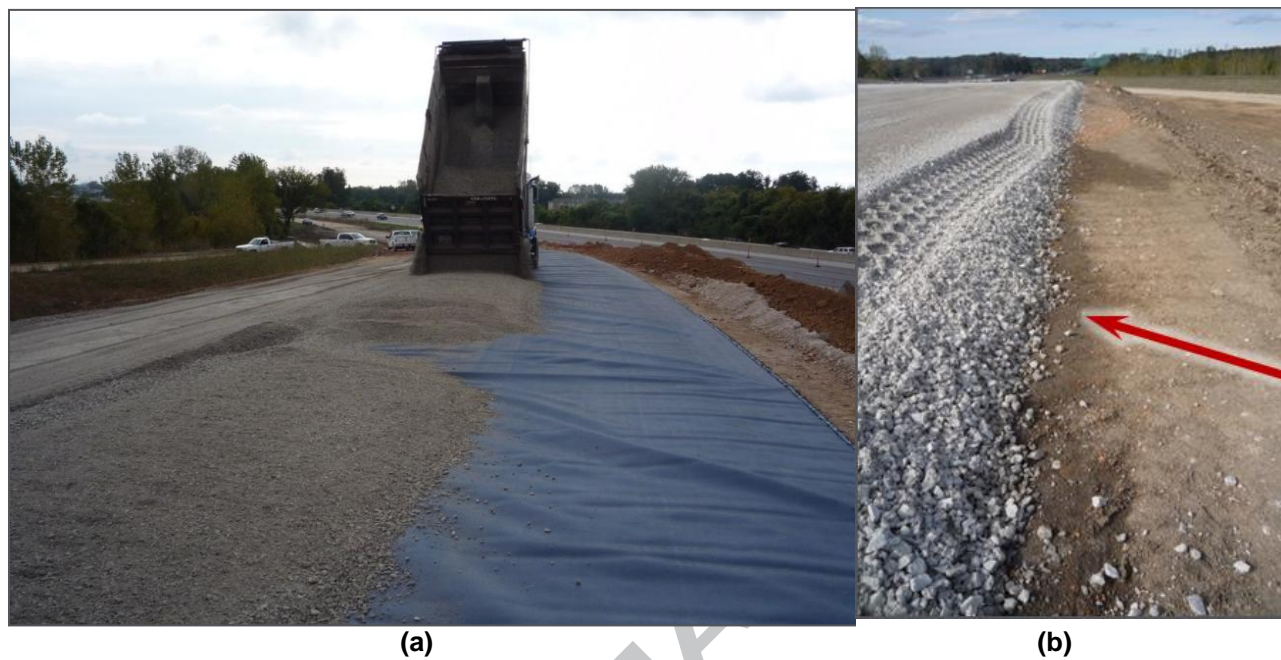
Figure 7: Construction of bridge approaches to Daniel Boone Bridge: (a) placement of base aggregate over drainage geotextile, (b) visible drainage at edge of geotextile after placement
Note: Arrow points to indication of visible effective drainage

The first pavement sections to include the ELD geotextiles were constructed in October 2013. Figure 7(a) shows the placement of aggregate over the ELD geotextile. Just a few days after installation, heavy rains allowed for assessment of the drainage system. As shown in Figure 7(b), effective release of the excess moisture can be clearly observed draining beyond the moisture discharge termination segment of the geotextile. The new eastbound and westbound bridges opened to traffic in June and November 2015, respectively. Good performance has been observed in the pavement sections since construction, showing no signs of distresses after opening to traffic. In summary, the Daniel Boone Bridge project illustrates a case involving a high water table, where an ELD geosynthetic was successfully used both to laterally divert upward migrating water and to replace 2 in. of expensive drainable base.

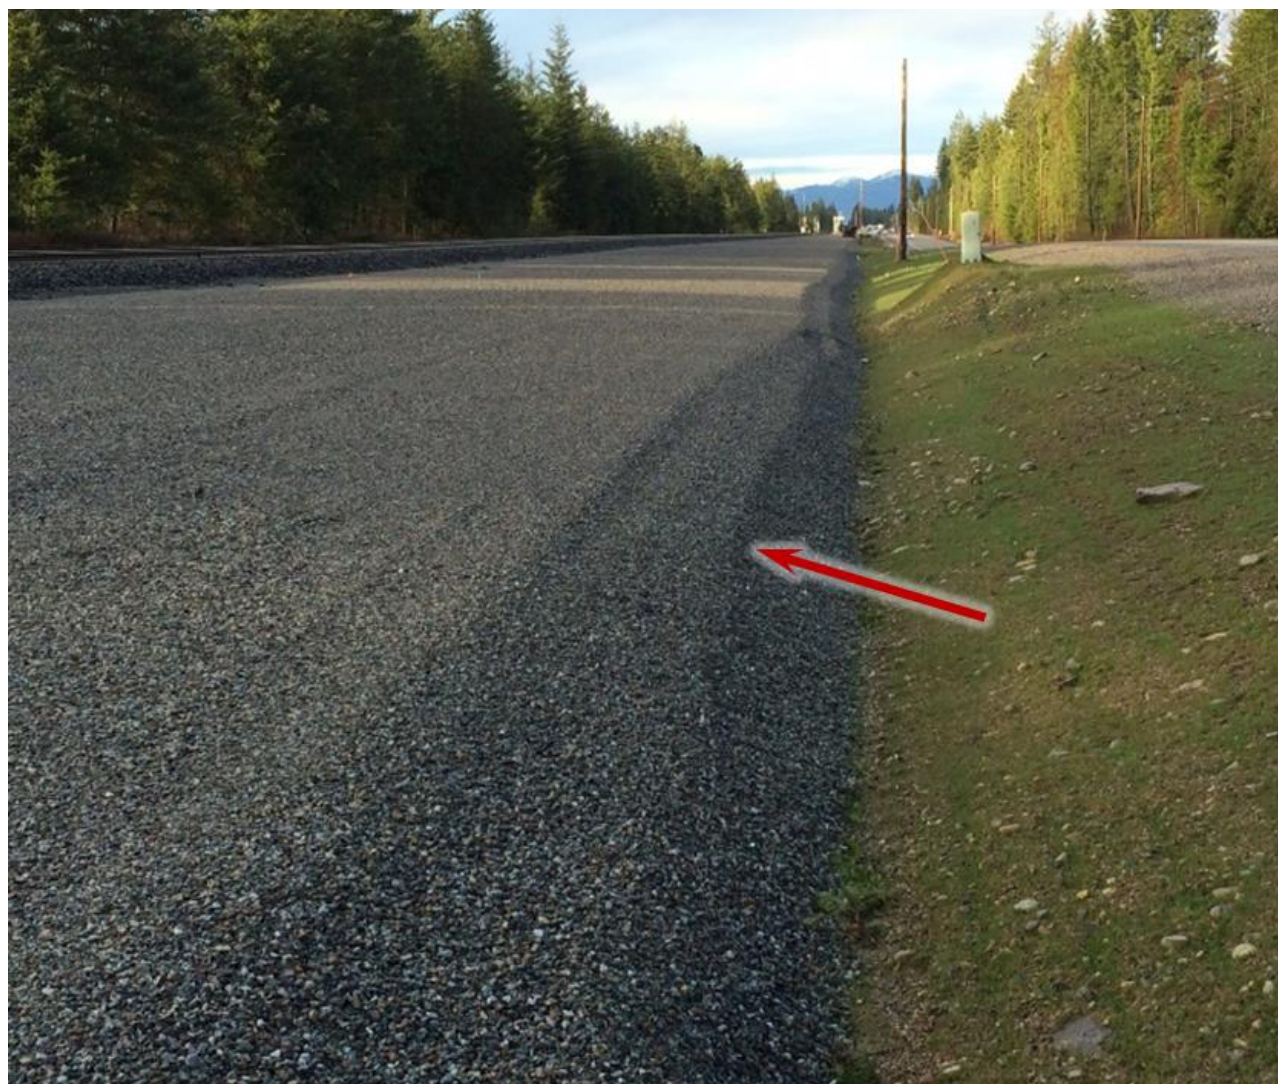
Figure 10: Completed Garwood Railroad Siding project with visible moisture line at geotextile level

Note: Arrow points to indication of visible effective drainage

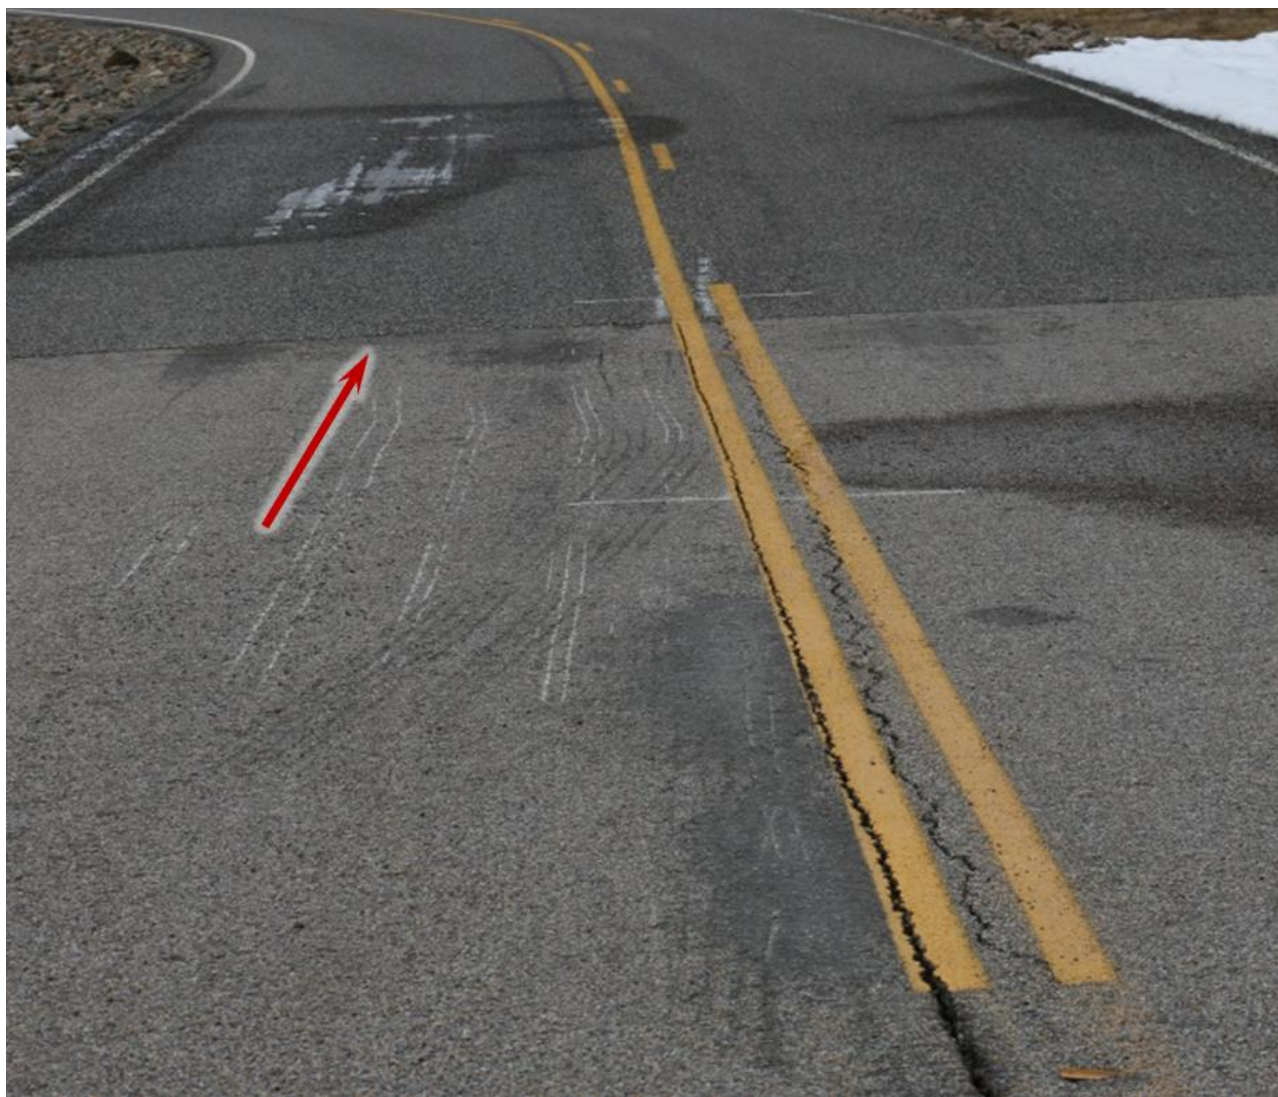
Figure 15: View of sections rehabilitated with ELD (top) and without ELD (bottom). Note longitudinal crack in section without ELD, which does not propagate into section with ELD
Note: Arrow shows where the old road meets the new road

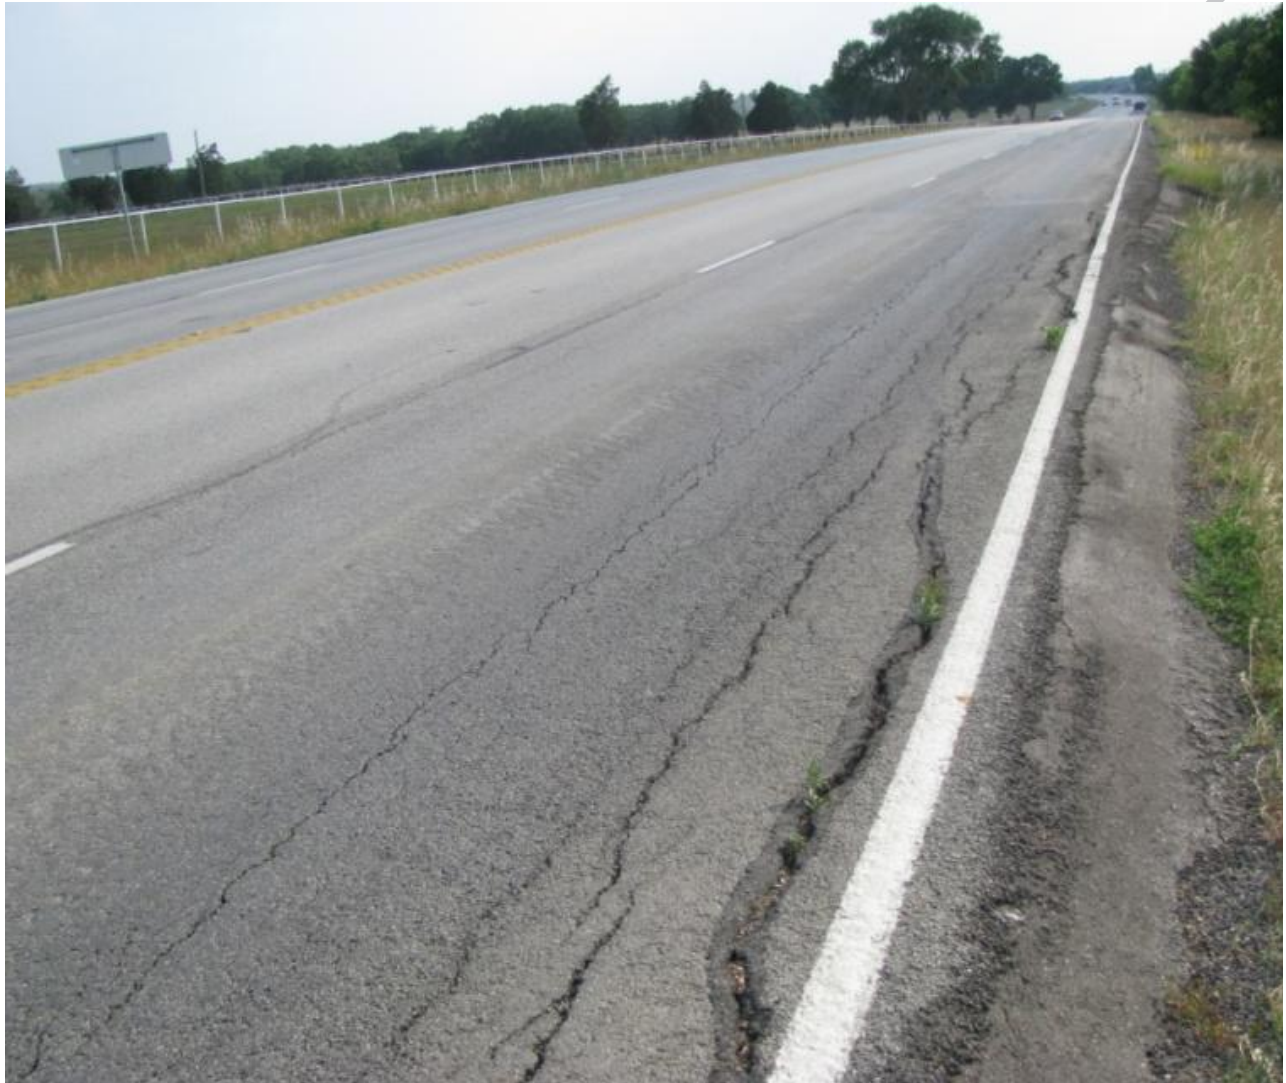
Figure 17: Extensive cracking of SH21 in 2012, as observed before rehabilitation of the road

A 6 mile (10 km) stretch of Texas State Highway 21 (SH21), just north of Bastrop, TX, was founded on an expansive clay subgrade, rehabilitated by the Texas Department of Transportation (TxDOT) in 2013. Prior to rehabilitation in 2013, the road had been subject to continued maintenance operations. Yet, rating of this road's pavement performance conducted by TxDOT prior to the 2013 rehabilitation still revealed inadequate performance: while 26% of the road was performing comparatively well; 32% of the road showed edge cracking; 38% of the road had patches and level-ups; and 4% of the road had longitudinal cracks within the inner and outer lanes. The recurrence of the road's inadequate performance was extensively evaluated, and despite numerous maintenance operations, pavement degradation was not halted. The extent of the pavement degradation in 2012, which was characterized by longitudinal and edge cracks, can be seen in Figure 17. A comprehensive characterization of the subgrade revealed that the

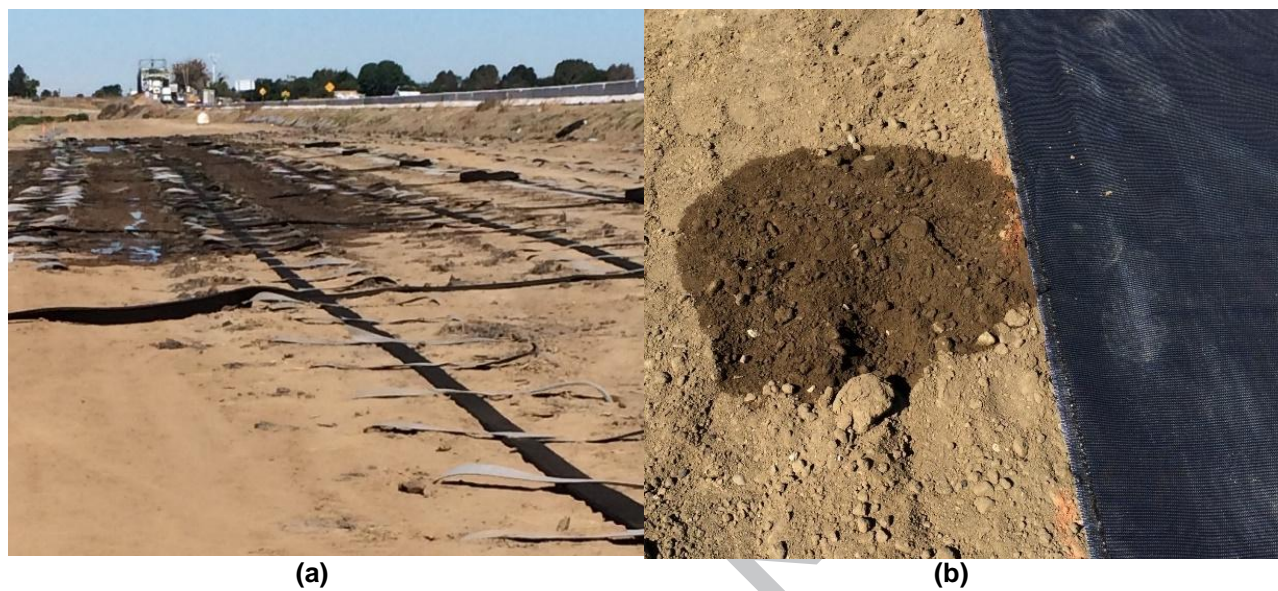
Figure 21: Implementation of SR12 soil improvement project: (a) View of PVD for accelerated consolidation; (b) View of effective drainage through ELD geosynthetic

Figure 21(a) shows a view of PVD, right after installation in a triangular pattern along the length of the new road. The ELD geotextile was placed directly on top of the ground level and PVDs. Lateral drainage through the ELD geotextile could be observed soon after its placement, as shown in Figure 21(b). At the time of preparation of this paper, staged loading through construction of the temporary fill was being completed. Use of an ELD geotextile in this project provided the required lateral drainage, while simultaneously offering additional separation and reinforcement of the soft foundation soils.
