International Journal of Mining Science and Technology

Preventing roof fall fatalities during pillar recovery: A ground control success story

Mark Christopher*, Gauna Michael

MSHA, Pittsburgh Safety and Health Technology Center, Pittsburgh, PA 15236, USA

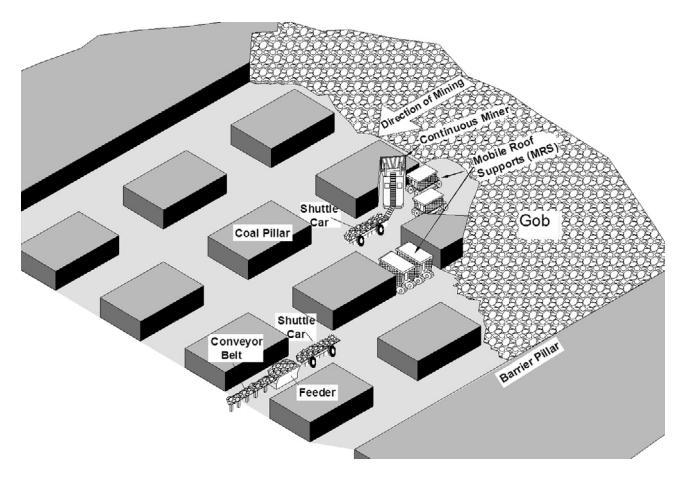
Fig. 1. Retreat phase of room-and-pillar mining showing pillar recovery.

During the retreat mining process the roof above the workedout area caves and the overburden subsides (Fig. 1). Because premature caving can cause hazardous roof falls while the miners are still present, pillar recovery has historically been less safe than other underground mining methods. A century ago, Rice found that of 317 miners that were killed by roof falls in one year in Pennsylvania, 98 perished while attempting to recover pillars, showing that "Drawing pillars is plainly most dangerous work" [1].

As noted in Fig. 1, the gob is the area where the pillars have been extracted and the roof has caved.

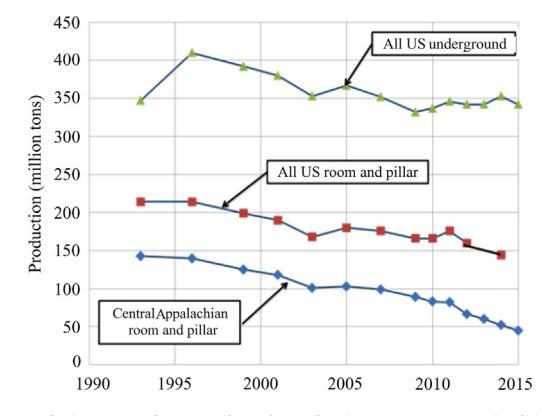
Fig. 2. Trends in US underground coal production, 1993–2015 cited in Energy Information Agency in 2015.

Fig. 2 shows that Central Appalachian room and pillar production declined slowly between 2001 and 2011, from 108 to 82 million tons. During this same period, however, productivity also declined, from 3.12 to 1.59 tons per worker hour. Therefore, the number of miners exposed to pillar recovery likely increased during this period, peaking in 2011 (Fig. 3). NIOSH estimated in 2001 that about 10% of all underground hours were engaged in pillar recovery, and this estimate was probably valid through 2011. The

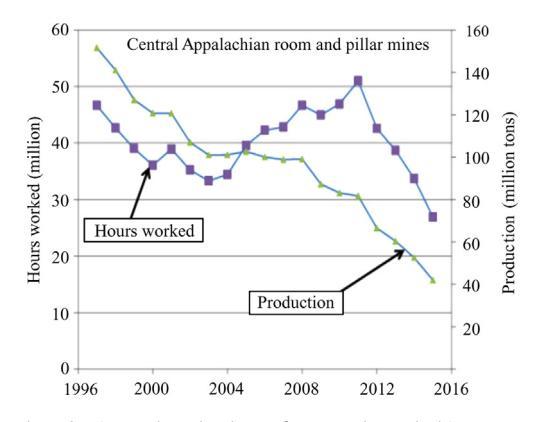
Fig. 3. Coal production and worker hours for Central Appalachian room-and-pillar mines, 1993–2015, cited in Energy Information Agency in 2015.

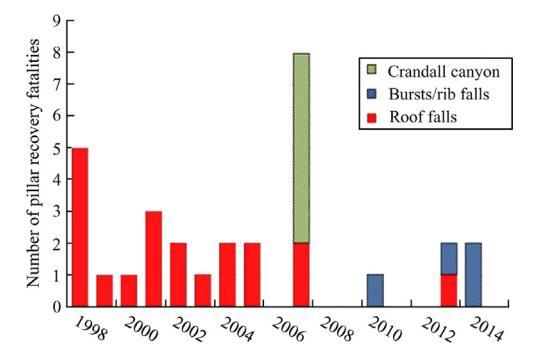
Fig. 4. Ground fall fatalities during pillar recovery, 1998-2015.

In recent years, the number of roof falls during pillar recovery has been dramatically reduced, however. As shown in Fig. 4, there has been just one roof fall fatality in the eight years since 2007. This compares to a total of 19 in the prior decade. Since the total exposure to retreat mining has only recently fallen, it seems that a retreat miner's risk of being killed by a roof fall was reduced by a factor of 16 (for the ten-year period 1998–2007, DOE statistics show that an average of 38.44 million hours were worked each year in Central Appalachian room and pillar mines. For the eightyear period 2008–2015, the annual average was 41.44 million hours. Therefore, there was one roof fall fatality during pillar

recovery for every 20 million hours worked in decade prior to 2008, and one for every 331 million hours in the eight years since.). The focus of this paper is on how this historic improvement was achieved.

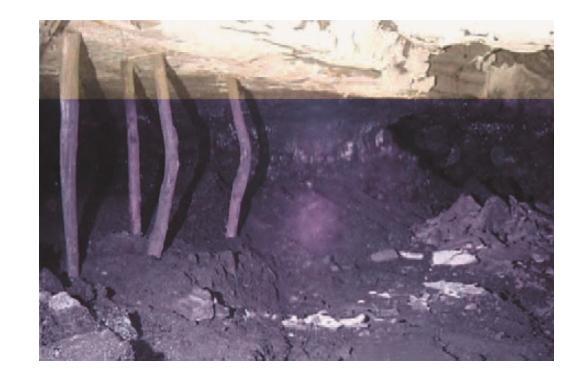
Fig. 5. A final stump.

One result of the traditional emphasis on complete extraction was the large number of miners killed while extracting the final pushout stump (Fig. 5). Montague found that 50% of the 67 retreat mining fatalities, and he analyzed occurred during the mining of the pushout [8]. Similarly, Mark et al. found that final stumps accounted for 45% of the 26 retreat mining fatalities between

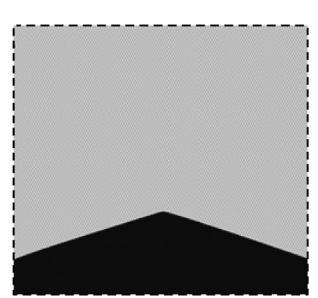
(a) Lifts taken from the cross cut

(b) No lifts taken from the cross cut

Fig. 6. Plan views of two types of final stumps.

Final stump: leaving the final stump is perhaps the biggest change with the new paradigm. Rather than viewing the stump as a hindrance to "necessary" caving, the stump is now seen as an essential roof support. A 2013 survey of roof control supervisors in the five Central Appalachian MSHA Districts found that 98% of retreat mining roof control plans now leave a final stump in place. In some cases these stumps are as small as 1.8 m by 1.8 m, but they are more commonly at least 2.4 m by 2.4 m (Fig. 6a).

The survey also found that in many plans no lifts at all are taken from the crosscut. In these plans the "final stump" is the entire outby end of the pillar. In two Central Appalachian MSHA Districts, apparently about 80% of the retreat pillars are mined this way (Fig. 6b).

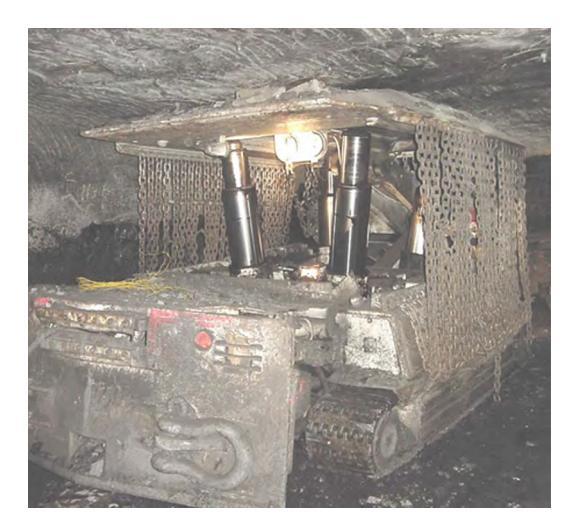
Fig. 7. A mobile roof support.

Mobile roof supports (MRS) are shield-type supports mounted on a crawler frame (Fig. 7). The advantages of MRS over timber supports are that they: (1) reduce miner exposure to roof falls at the pillar line since they can be operated remotely, (2) provide an active support pressure to the roof at the pillar line, (3) provide larger overall capacity (one 600 ton MRS is approximately equivalent to 12 posts), (4) maintain load through a much greater range of displacement, and (5) decrease the potential for material handling injuries.

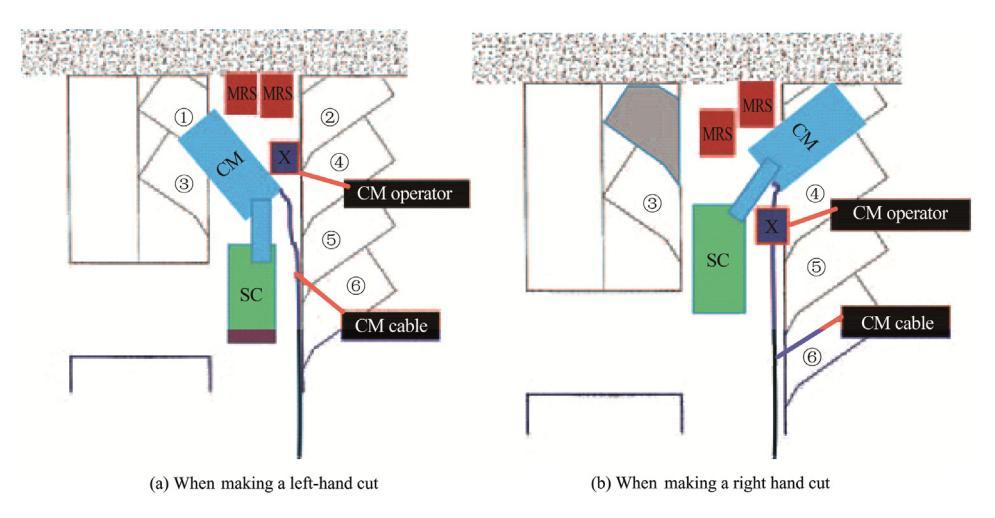
Fig. 8. Position of the continuous miner operator during pillar extraction (X) with a machine cabled on the right-hand side.

The position of the continuous mining operator is another concern. The CM operator normally must handle the miner cable, keeping it against the pillar rib and out of the way of the shuttle cars. The CM operator must also stay clear of the CM boom, the haulage cars, and possibly hazardous ribs. For all these reasons, when taking the left-hand cut with a machine cabled on the right, the CM operator is usually located inby the CM, between the CM and the MRS (or turn posts). One disadvantage of this inby location is the potential lack of egress, particularly when the CM is just beginning its cut (Fig. 8a). When taking the right-hand cut, the CM operator usually stays close to the right rib, outby the CM, and can handle the cable from here and stay out of the way of the boom and the shuttle cars, and also is outby all previous lifts (Fig. 8b).

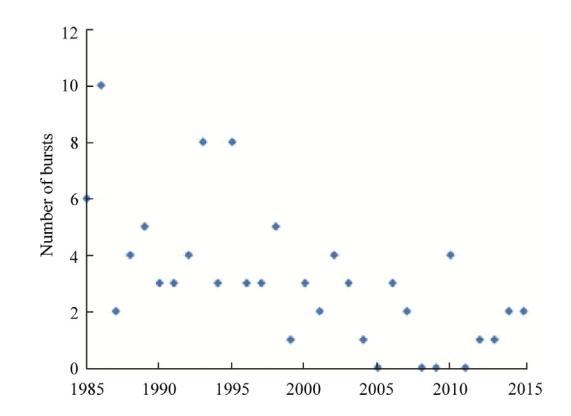
Fig. 9. Bursts in US coal mines (excluding the longwall face), 1984-2015.

The incidence of non-longwall bursts in room-and-pillar mines has decreased significantly with time. Fig. 9 shows that during the 1980 s and 1990's, there were about six bursts per year in locations other than the longwall face. The rate has fallen to less than 2 per year since then. There have been just six non-longwall bursts since 2010.
