Legionella Management for Building Water Systems

BY LAN CHI NGUYEN WEEKES, P.ENG., MEMBER ASHRAE; DONALD M. WEEKES, CIH, MEMBER ASHRAE

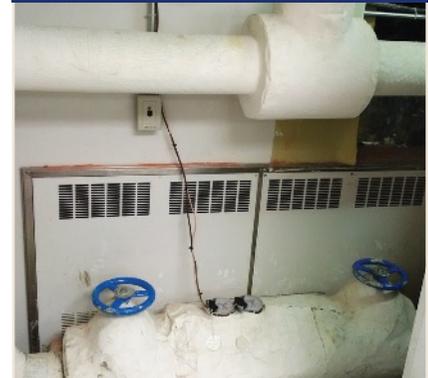
FIGURE 1 Dead leg (bottom) located in a closet in a basement.

The building operators are also invaluable to the team since they often know where cross-contamination/by-pass/dead legs in the water lines occur (Figure 1). This is especially useful when such a problem is located in a closet in the basement, or where most of the water systems are not located, like above the ceiling in an office. The building operators will often share their frustration due to the lack of access to certain equipment for maintenance purposes. They also will discuss peculiar maintenance practices such as throwing in a few pucks of chlorine now and then (no specific schedule) into the cooling tower water basins.

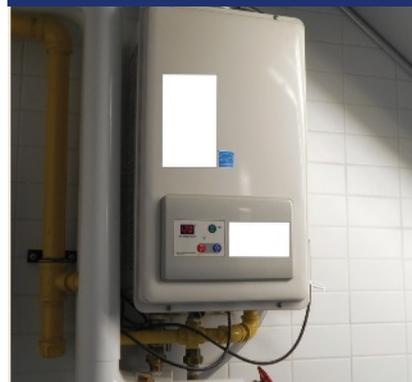
FIGURE 2 Tankless domestic water heater.

Different types of devices such as tankless water heaters and point-of-use small water heaters are becoming more prevalent in new and renovated buildings (Figure 2). Both types

Tankless water heaters generally heat the water at the point of use, and therefore they are eliminating water stagnation in a reservoir, which reduces the risk of *Legionella* growth. Although small water tanks at the point of use can limit water stagnation in the water line leading to the fixture, they can still have water stagnation in the tank at infrequently used locations. Moreover, they generally do not have any means for water recirculation or water temperature control. Close monitoring of point of use equipment (especially small water tanks) is essential since they tend to be located in areas that are not visible (under kitchenette counters) or inaccessible (ceiling-mounted).
